Churchtown Conservation Area Appraisal and Management Plan

Churchtown Conservation Area Appraisal

Wyre Borough Council

Adopted 19th July 2010

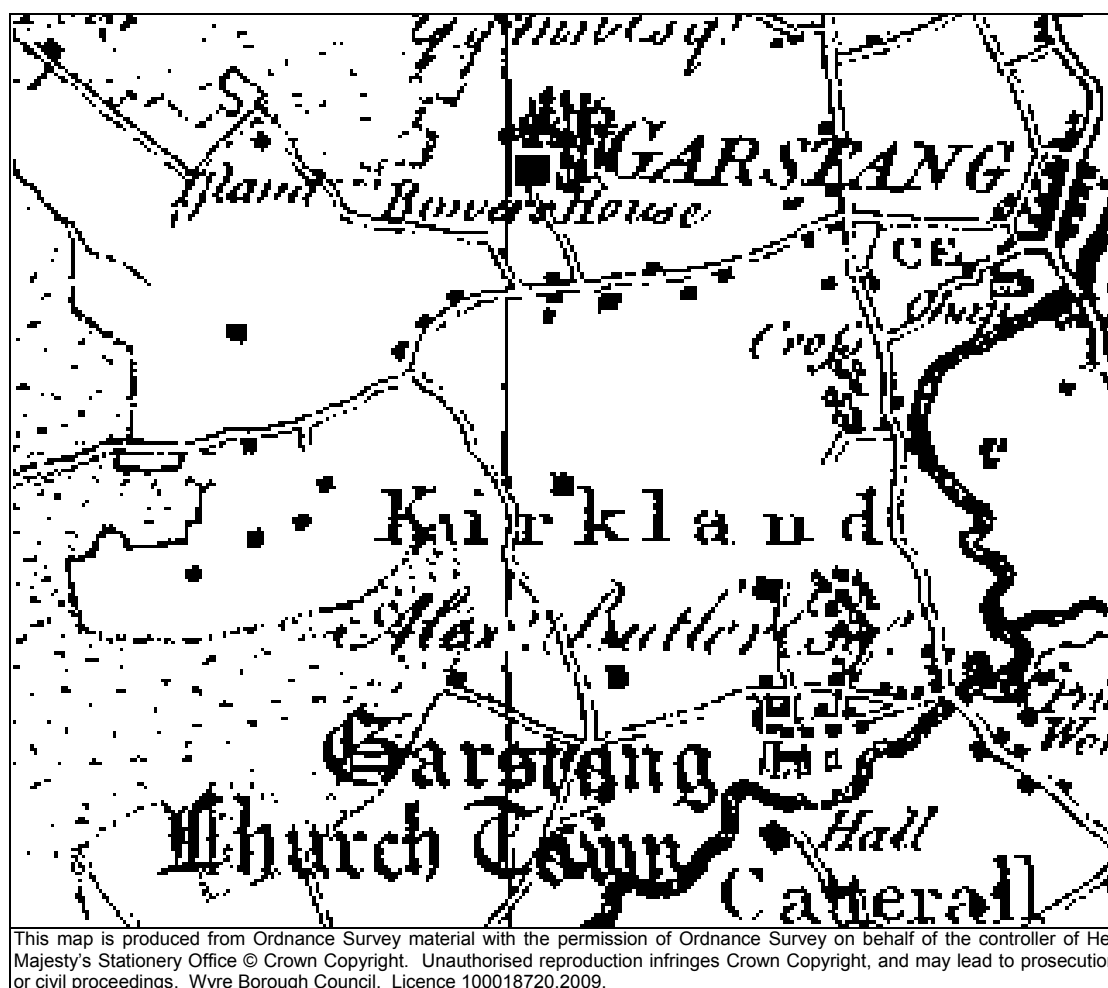
FIGURE 3. CHURCHTOWN AS GARSTANG CHURCH TOWN AND THE DISTANCE FROM GARSTANG

The map illustrated in Figure 3, shows Churchtown as it was originally referred to – Garstang Church Town, and also shows the relative distance away from Garstang itself.

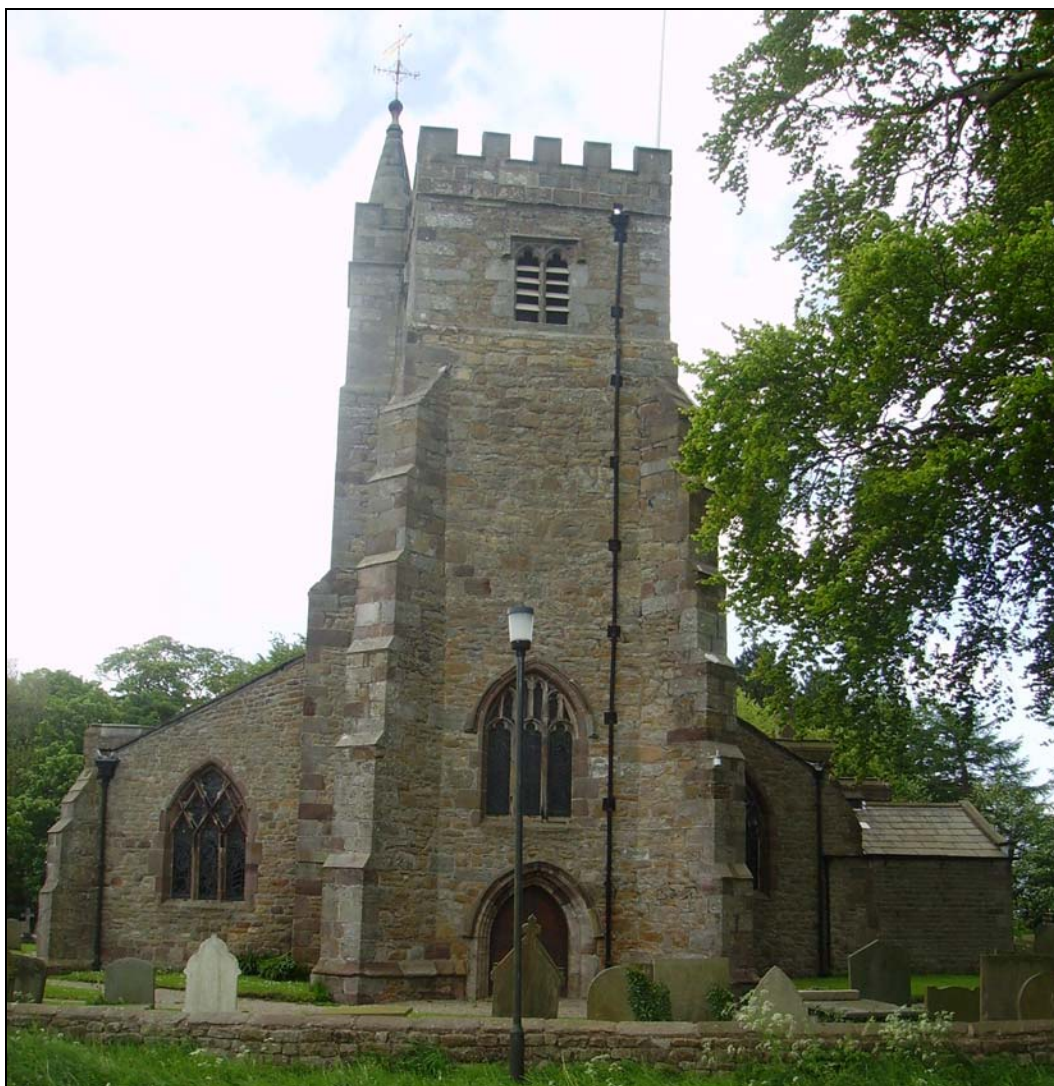
FIGURE 4. THE PARISH CHURCH OF ST HELENS

On the south side of the village, the Parish Church, St Helen's is situated. This is the mother church for the surrounding nine parishes and is thought to contain an example of nearly every architectural style since the Norman Conquest (Bilsborough, 1989). The exact date from which it was founded is unknown but there was certainly a church here in the 12th Century (Hewitson, 1900). In 1864, a restoration committee was set up consisting of the vicar and the churchwardens (Hewitson, 1900). Subscriptions were gradually obtained to restore the church, with the architect, Mr Paley, giving instruction (Hewitson, 1900). This restoration included the reseating of the entire church in oak, the floor was replaced, and all stonework was cleaned and painted (Hewitson, 1900). The entire process of restoring the Church took around five years to complete and cost £1,371 13s 1d (Hewitson, 1900).

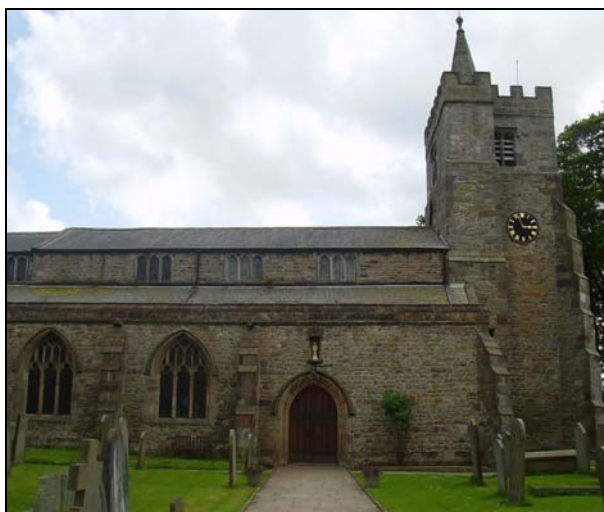
FIGURE 13. CHURCH OF ST HELEN

The Grade I Church of St Helen was listed on 17th April 1967, with the last amendment to this being on the 19th January 2007. The church building is thought to originate from the fifteenth century, with remains of previous church buildings dating from 1220 and 1300. There are also alterations that occurred in the sixteenth century, and in 1811, and the building was fully restored in 1865-8. The building comprises of a west tower, a nave and lower chancel, north and south aisles, northeast vestry, south porch and south chapel. The tower has diagonal buttresses and a stair turret, as well as an embattled parapet.

Inside the church, the five-bay nave arcades have pointed arches, and probably date from the fifteenth century. Two pointed arches lead to the south chapel, which has a lean-to roof with moulded beams, and a wall plate with Latin inscription and date 1529. The pulpit incorporates 17th century carved woodwork and date '1646'. Two of the rows of choir stalls incorporate medieval woodwork, with carved misericordes.

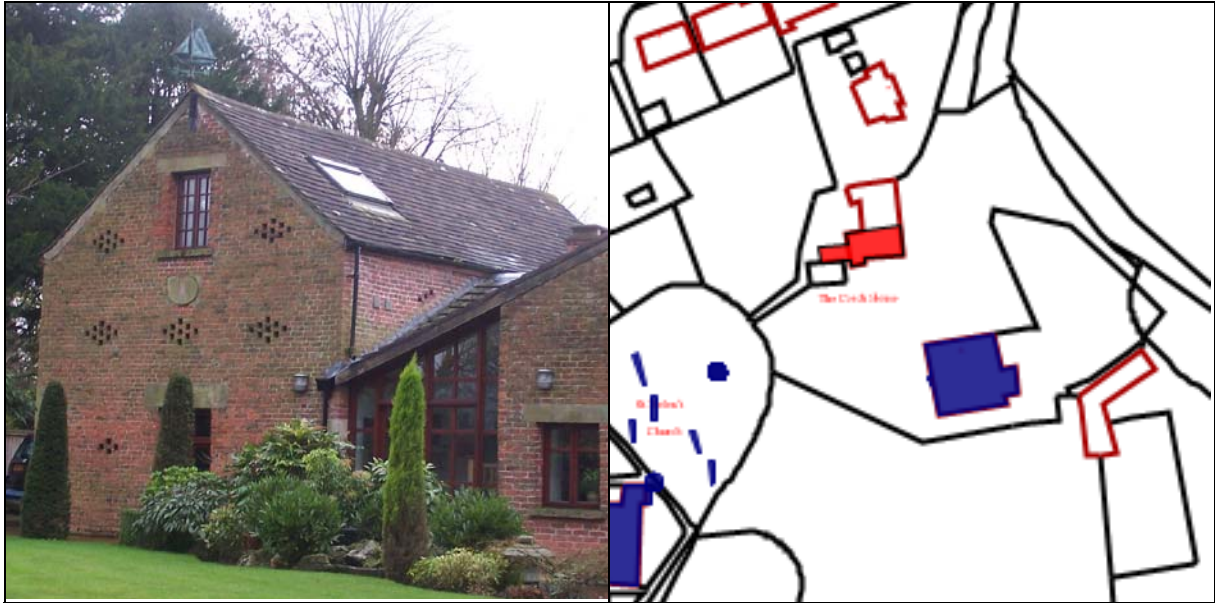
FIGURE 15. BARN NORTH WEST OF OLD VICARAGE

This brick and sandstone barn with a tile roof, Grade II Listed on 29th October 1985, is thought to date from 1755. There are two doorways on the south wall, both with stone lintels although the right-hand one is blocked. To the right, the lower part of the wall has stone quins. The east (gable) wall also has a doorway with stone lintel. Above this is a pitching door and below is an oval plaque inscribed: 'JP Vicar Anno Domini 1755'.

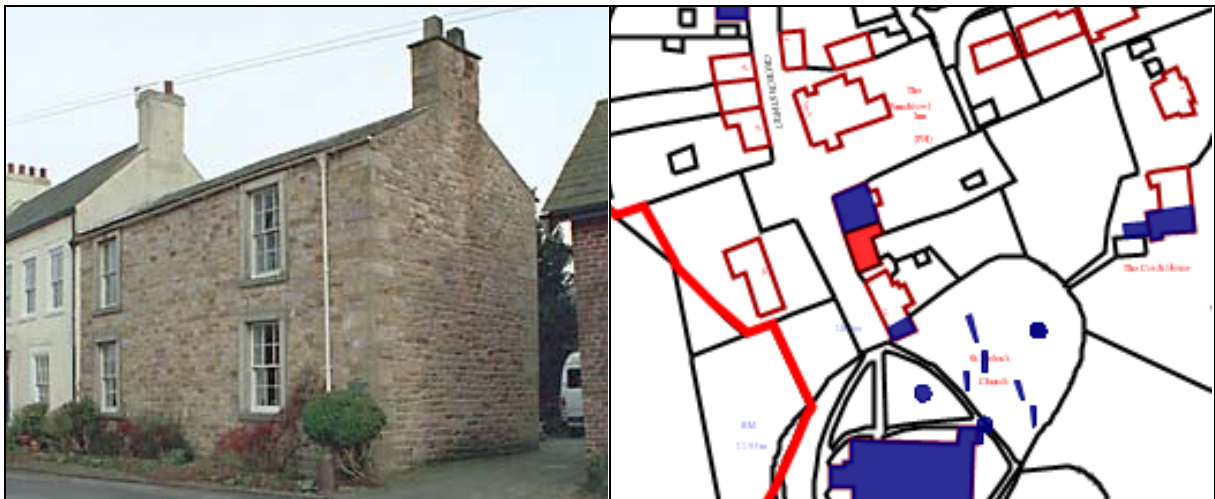
FIGURE 17. CHURCHGATE COTTAGE

two 2 bays with sashed windows with glazing bars in a ‘six over six’ vertical arrangement and plain stone surrounds.

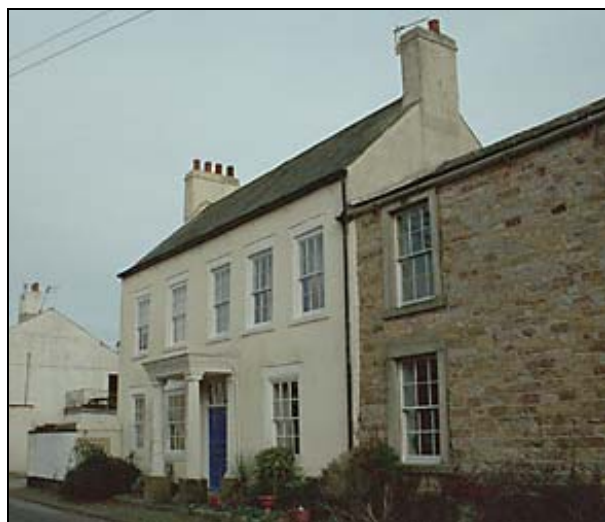
FIGURE 19. CHURCHGATE HOUSE

As with Churchgate Cottage, Churchgate House was also Grade II listed on 17th April 1967. The building has documental evidence from 1698, although the current boxed sash windows with glazing bars also in a ‘six over six’ vertical arrangement and rendered surrounds appear to date from the mid to late eighteenth century. It is constructed of pebbledashed brick with a slate roof and of two storeys and five bays, with a twentieth century porch with two columns over the doorway in the central bay. There are two chimneys, each being at the gable ends.

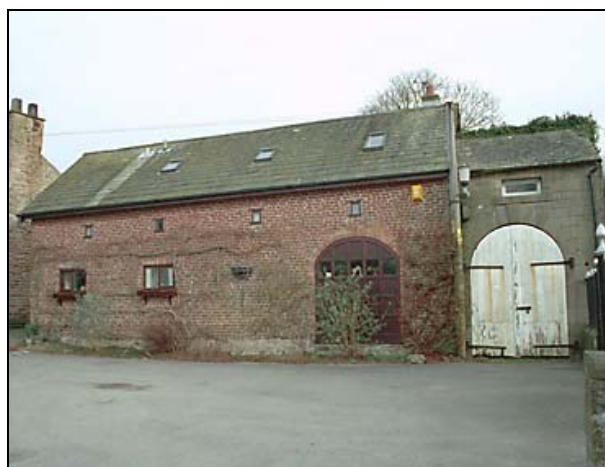
FIGURE 21. COACH HOUSE

Listed at Grade II on 14th July 1980, this Coach house is said to have been used as a hearse house and dates from the early nineteenth century. It is constructed of sandstone ashlar and has a slate roof, with small horizontal openings with sills below eaves level.

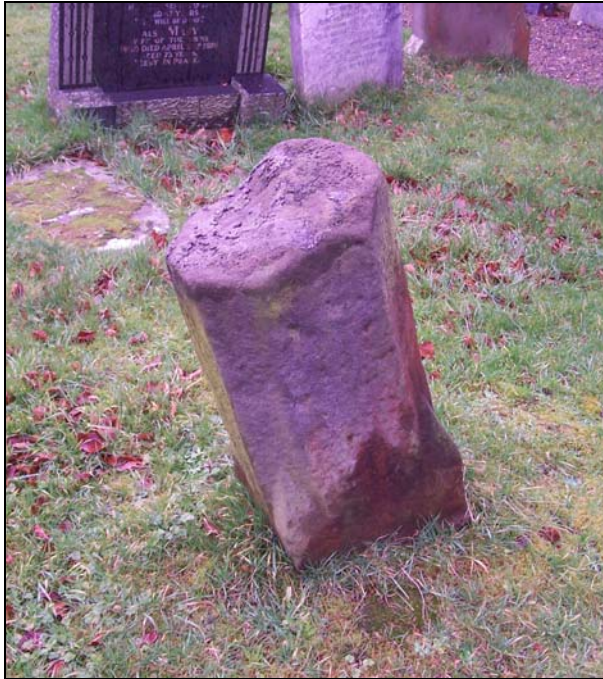
FIGURE 25. CROSS SHAFT SOUTH OF ST HELENS

Grade II Listed on the same date as the cross above, this cross shaft is thought to be of medieval date, and is constructed of sandstone and on a rectangular plan. However, the upper part is broken off.

“Cross shaft, probably medieval, sandstone. Rectangular plan. Sides chamfered with pyramid stops. Upper part broken off.”

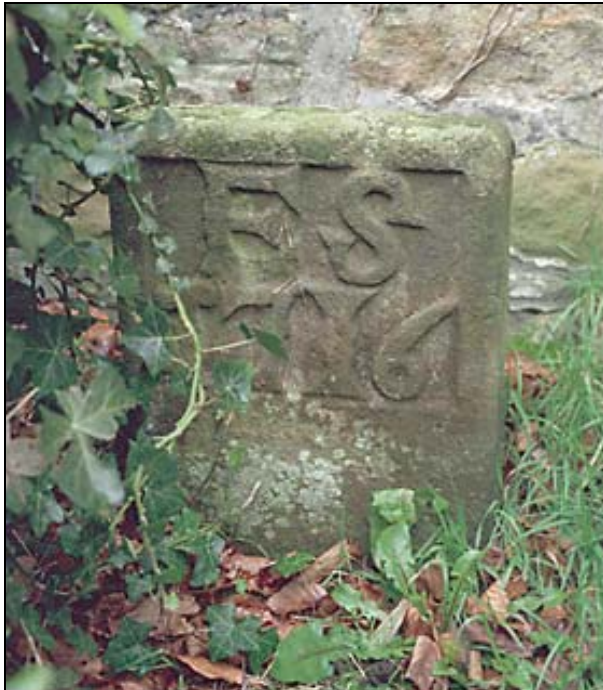
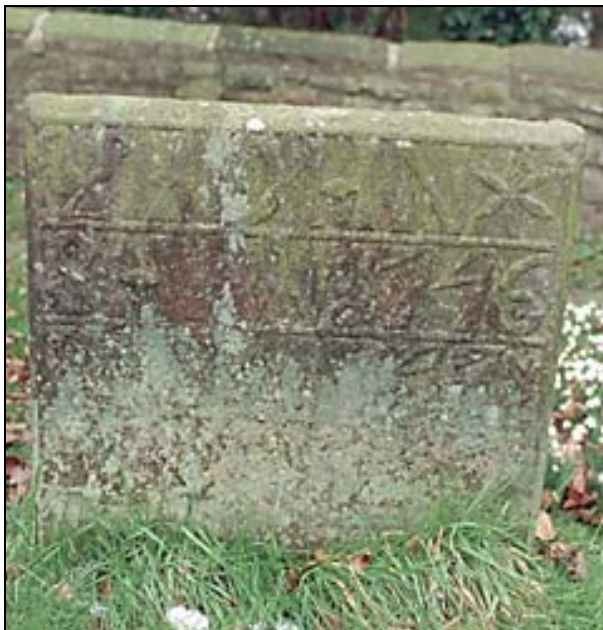
FIGURE 33. HEADSTONE AGAINST EAST WALL

Both of these headstones were Grade II Listed on 9th January 1986 and are of sandstone. The headstone against the east wall is dated at 1716 and inscribed: 'ES 1716'. The headstone east of the Vestry dates from 1746 and is inscribed: 'JOHN SHAW 1746....'.

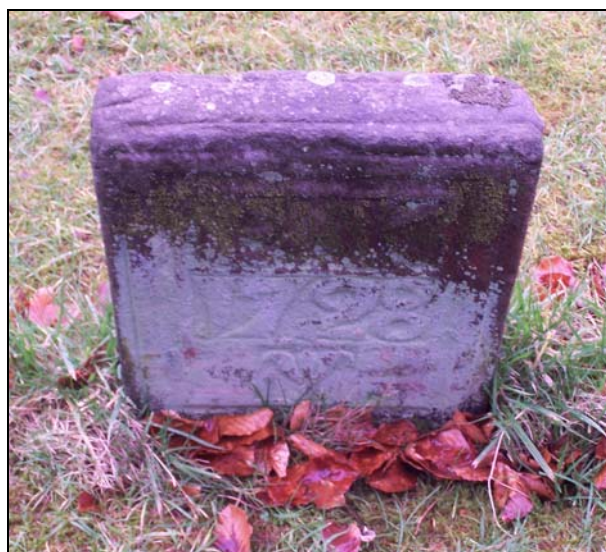
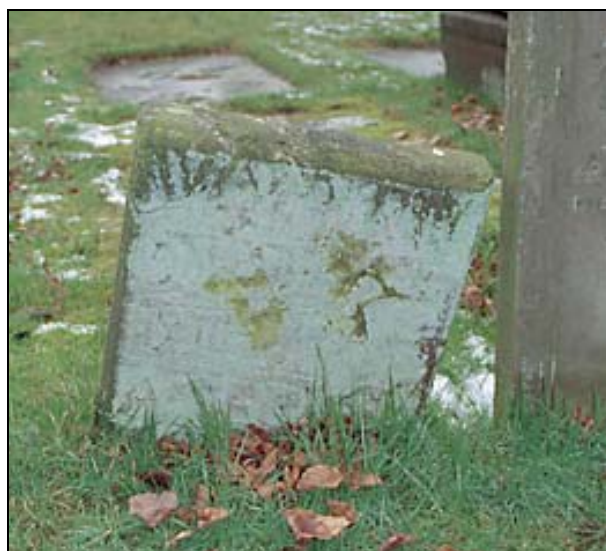
FIGURE 37. HEADSTONE NORTH EAST OF VESTRY

Listed at Grade II on 9th January 1986, both of these headstones are sandstone. The first headstone dates from 1728 and is inscribed: 'EK 1728'. The second headstone dates from the early eighteenth century and is inscribed: 'WM BURN DYD JUNE 19th 17-0 AGED 87'.

“Headstone, early C18, sandstone. Inscribed: 'WM BURN DYD JUNE 19th 17-0 AGED 87'.”

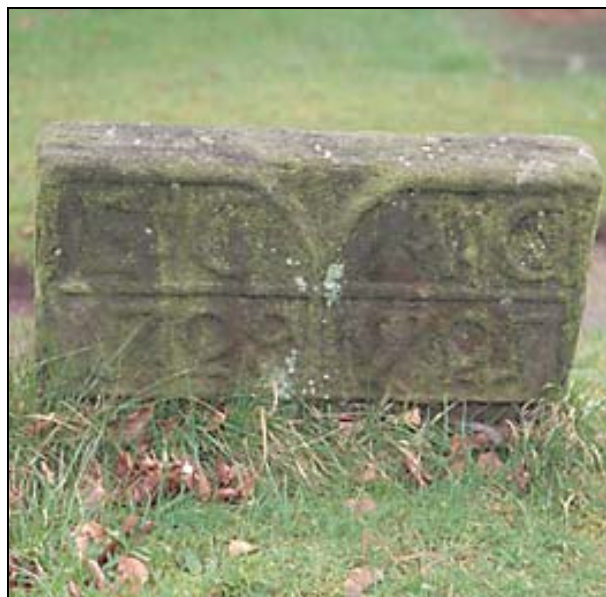
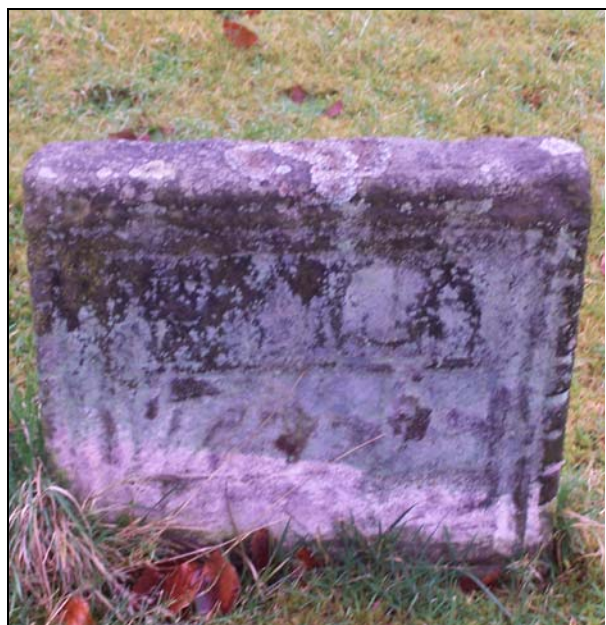
FIGURE 41. HEADSTONE NORTH OF CHURCH

FIGURE 43. HEADSTONE NORTH OF VESTRY

Listed at Grade II on 9th January 1986, both of these headstones are sandstone. The headstone north of the church dates from 1727/28 and is inscribed: 'BC 1728' at left, and 'AC 1727' at right. The headstone north of the Vestry dates from 1719 and is inscribed: 'EG 1719'.

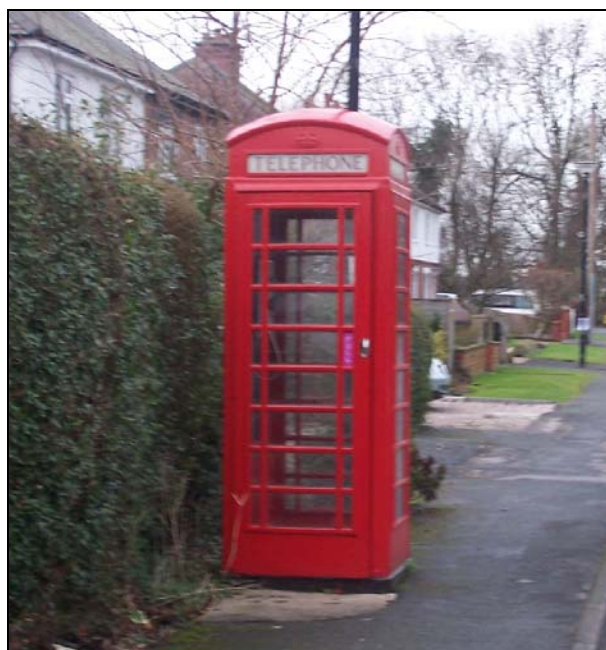
FIGURE 45. K6 TELEPHONE KIOSK

Listed on 20th December 1989 at Grade II, this K6 type telephone kiosk was designed in 1935 by Sir Giles Gilbert Scott, though various contractors built this type. It is constructed of cast iron and is square in form with a domed roof. There are unperforated crowns on the top panels and margin glazing on the windows and door.

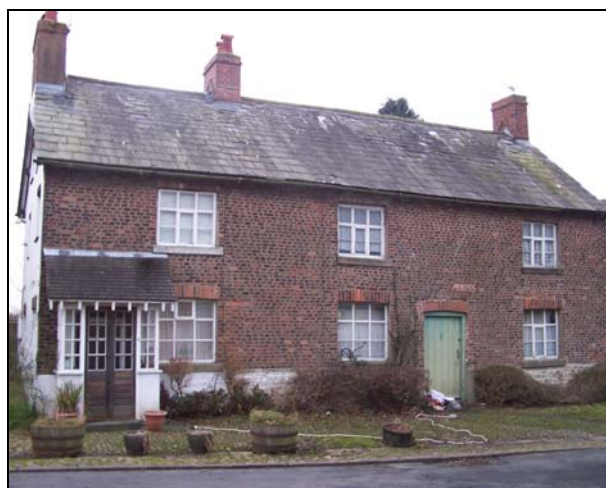
FIGURE 47. MANOR HOUSE AND MANOR COTTAGE

This pair of semi-detached houses dating from the early nineteenth century was Grade II listed on 9th January 1986. They are of two storeys and constructed of brick with sandstone windowsills and a slate roof. To the right is the Manor House, which

is of two bays, has brick reveals and heads to the windows and a door, between the bays, under a timber porch. To the left is Manor Cottage, which is of one bay with similar windows to that of Manor House. The door is at the left under a modern glazed porch. There are three chimneystacks, situated on the gables and between the houses.

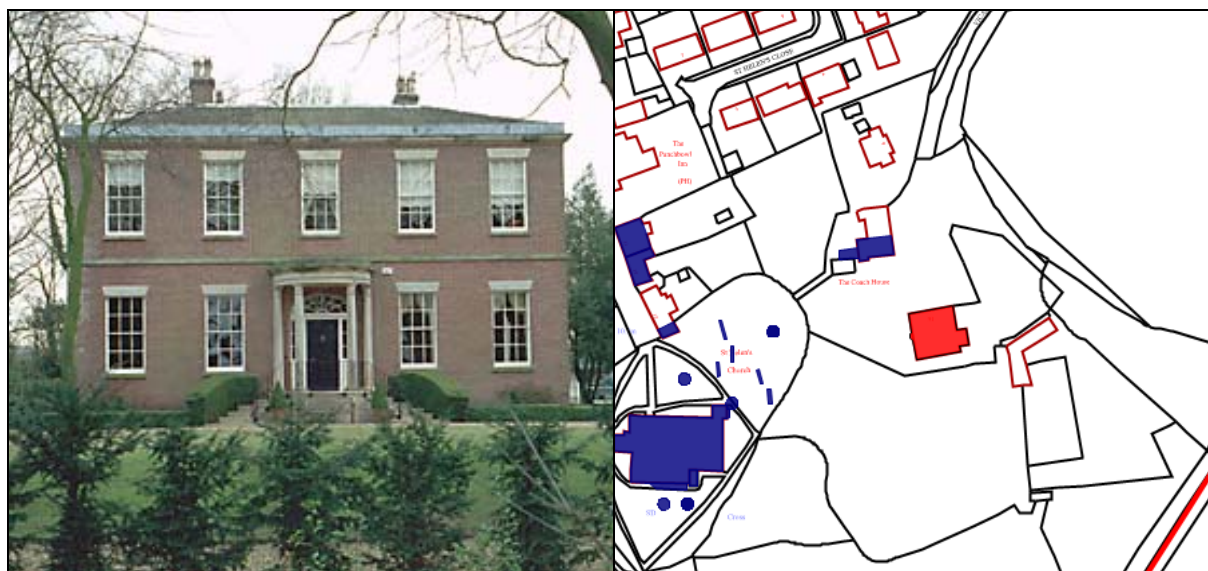
FIGURE 49. THE OLD VICARAGE

The doorway is located in the middle bay and has a semi-circular composite porch constructed of two freestanding columns as well as two columns attached to the building. Six steps approach the doorway on each side, with iron railings. There is a fan light above the door, which has an elliptical arch. The elevations to the side of the building are each of four bays and at the rear there is a Venetian stair window. Inside the building, there is a dogleg stair with balusters and a swept handrail.

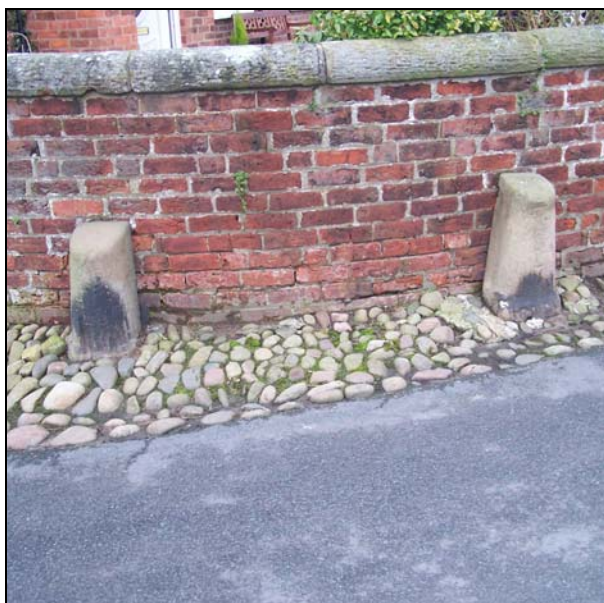
In Churchtown, due to the residential nature of the village, boundary walls are an important factor to consider. In the more historic section of Churchtown, in close proximity of the Church of St Helens, low walls close to the front elevation of the property is common, as can be seen in Figure 61. In the more modern section of the village, the majority of properties have hedges in place of boundary walls, as shown in Figure 62. However these hedges play the same role as boundary walls and are consequently important features to be retained.

FIGURE 61. LOW WALL IN FRONT OF PROPERTY

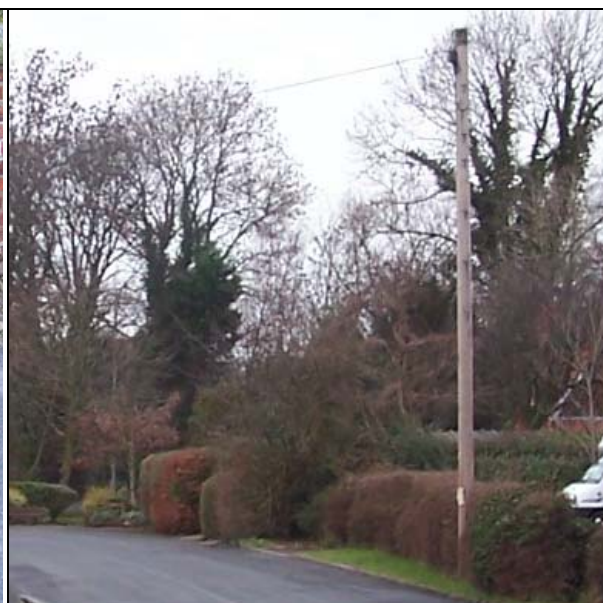
FIGURE 62. HEDGE IN PLACE OF BOUNDARY WALL

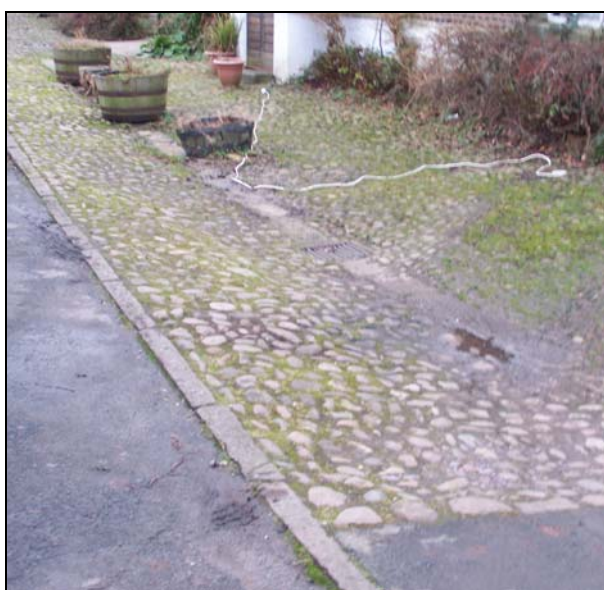
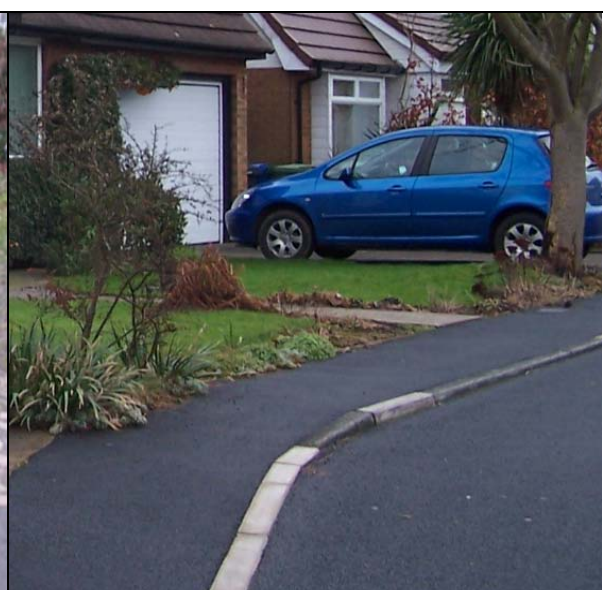
Where boundary walls have been removed, incongruous open areas are created, that generally do not fit in with their surroundings, as illustrated in Figures 63 and 64. In more recent years, this has seemingly been done in residential areas to allow for off-road parking.

FIGURE 63. REMOVED BOUNDARY WALL CREATING INCONSISTENT OPEN AREAS

FIGURE 64. LACK OF BOUNDARY WALL DOES NOT FIT WITH SURROUNDINGS

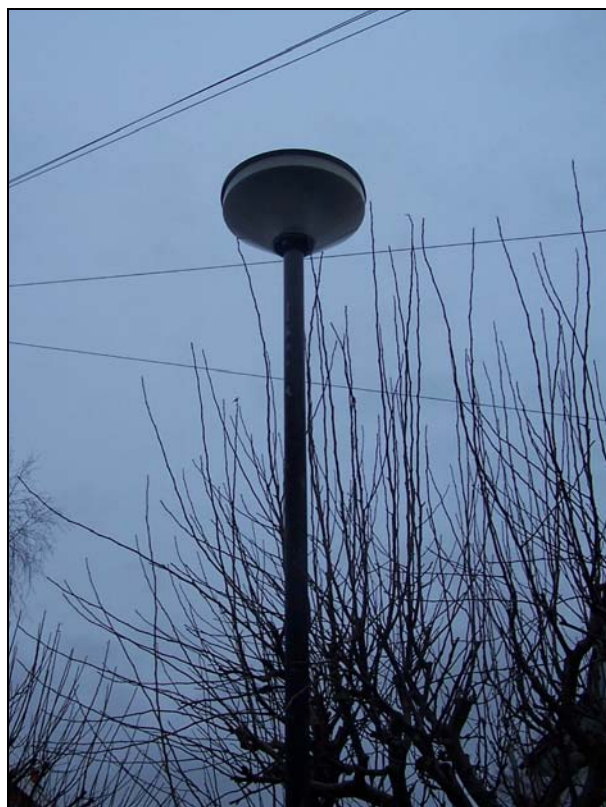
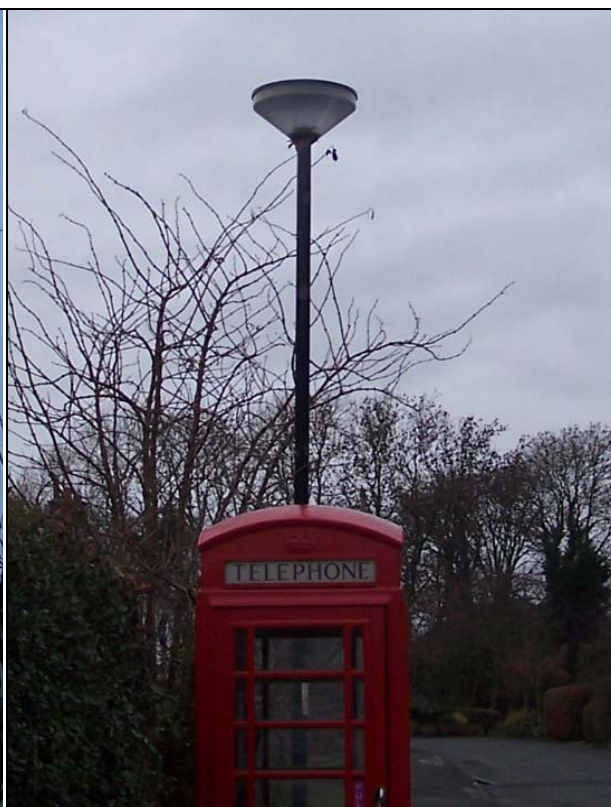
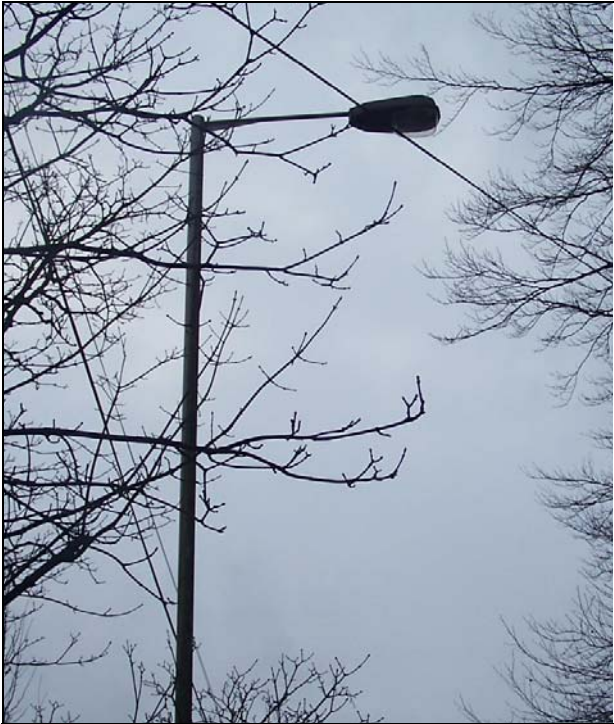
Within Churchtown Conservation Area there are two designs of street lighting, examples of which are shown in Figures 65 – 67. Both of these styles are considered to be very modern and not entirely in keeping with the character and appearance of the historic character of Churchtown Conservation Area. Figure 68 illustrates a more traditional appropriate style of lighting that should be considered when these lighting columns are replaced in the future. It is essential to have continuity within a Conservation Area in order to ensure that attention is not negatively taken away from the aesthetics of the area, a factor that, the designation of Conservation Areas attempts to protect.

FIGURE 65. MODERN STYLE OF STREET LIGHTING

FIGURE 66. MODERN STYLE OF STREET LIGHTING

FIGURE 67. MODERN STYLE OF STREET LIGHTING

- Two designs of street lighting, none of which are appropriate and should consequently replace all styles with more appropriate styles in the future;
- Numerous materials used in street surfacing, with cobbles, setts, concrete and tarmac being most common;
- Three designs of litter bins within the area, which should, in the future, be replaced for one single design;
- Signage can be found at the two pubs within Churchtown, both of which having appropriate signage;
- Two designs of benches within the area, which should, in the future, be replaced for one single design; and
- One Grade II Listed public telephone box.

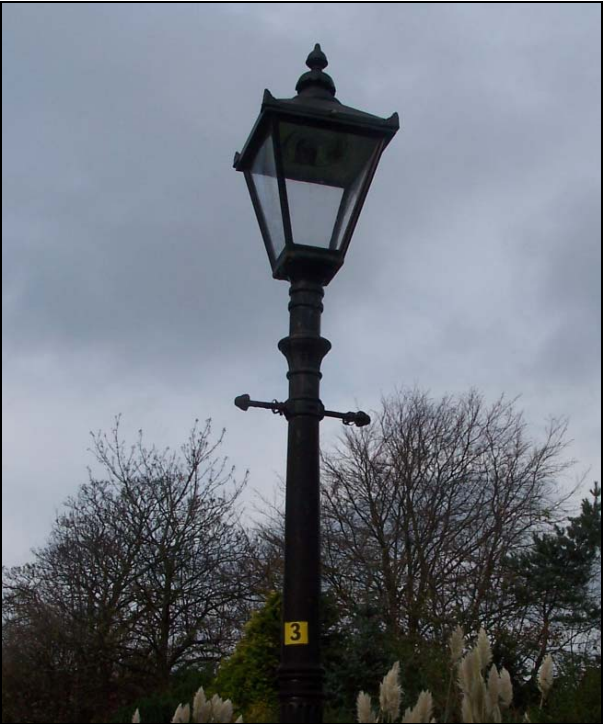
FIGURE 68. MORE TRADITIONAL APPROPRIATE STYLE OF STREET LIGHTING, NOT CURRENTLY IN CA

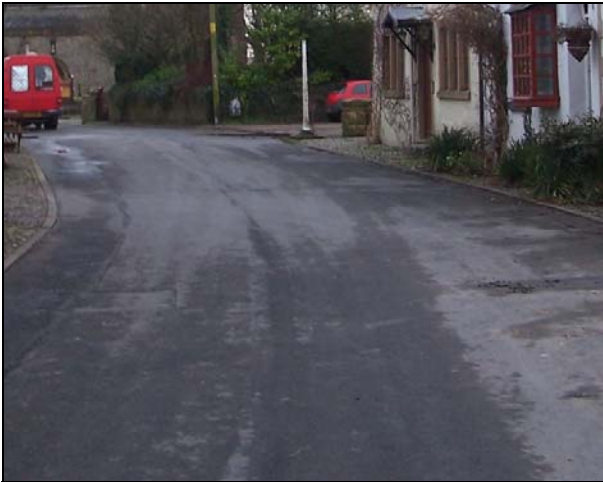
There are numerous different types of street surfacing within the Conservation Area; ranging from cobbles, to tarmac and concrete. Examples of these are illustrated in Figures 69 – 70. Pavement areas also range in material, being both cobbles in some areas and also concrete, as shown in Figures 71 and 72. These inconsistencies in materials detract from the character and appearance of the Conservation Area and should consist of one uniform material, for both road and pavement surfacing.

FIGURE 69. STREET SURFACING MATERIALS

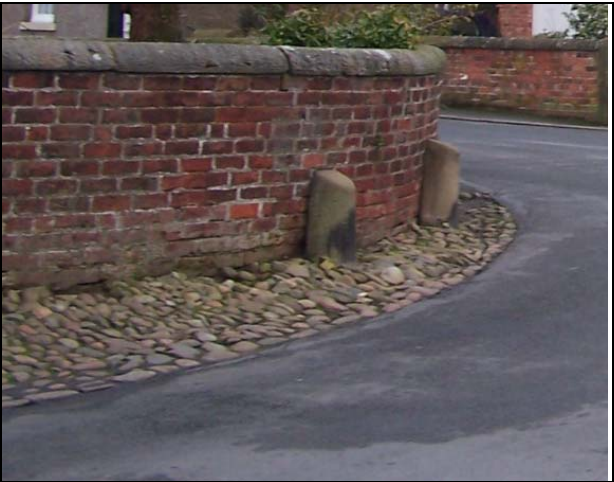
FIGURE 70. ROAD SURFACING BORDERED BY ROUNDED COBBLES

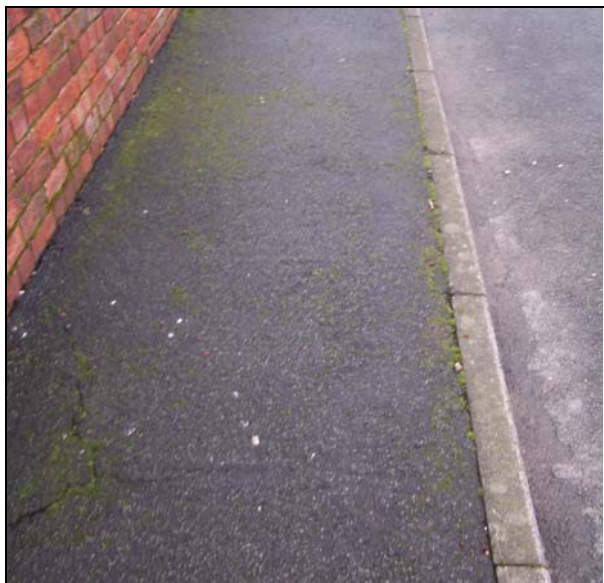
FIGURE 71. GENERAL PAVEMENT MATERIAL

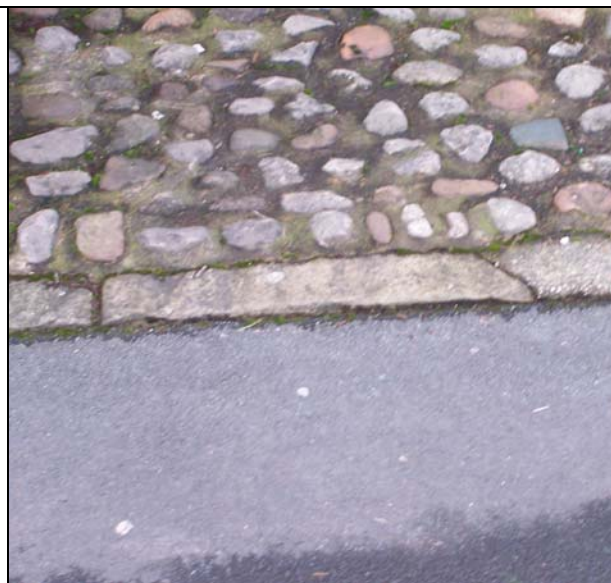
FIGURE 72. VARIATION IN PAVEMENT MATERIALS

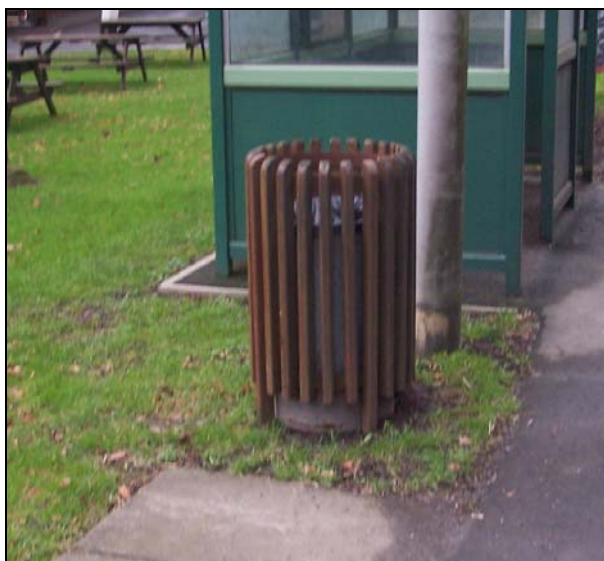
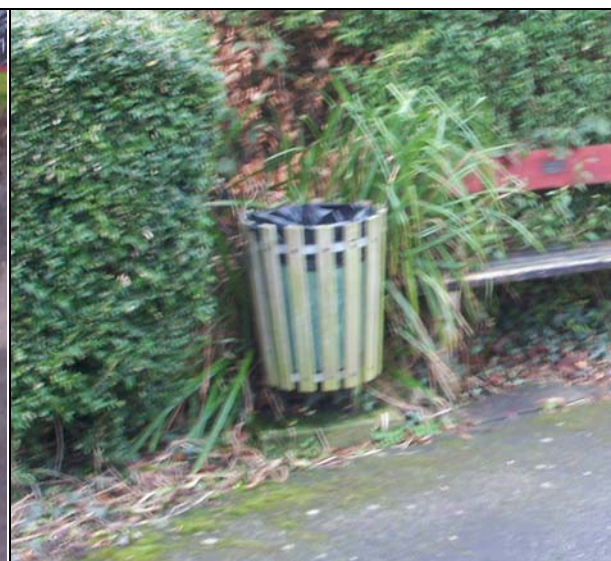
Within Churchtown there are three styles of litterbin, as shown in Figures 73 - 75. Due to these differing designs and materials, attention can be attracted away from the historical character of the Conservation Area. In order to ensure that this does not occur, one style should be chosen and uniformly used in all situations within Churchtown.

FIGURE 73. ONE STYLE OF BIN

FIGURE 74. DIFFERING STYLE OF BIN DESIGN

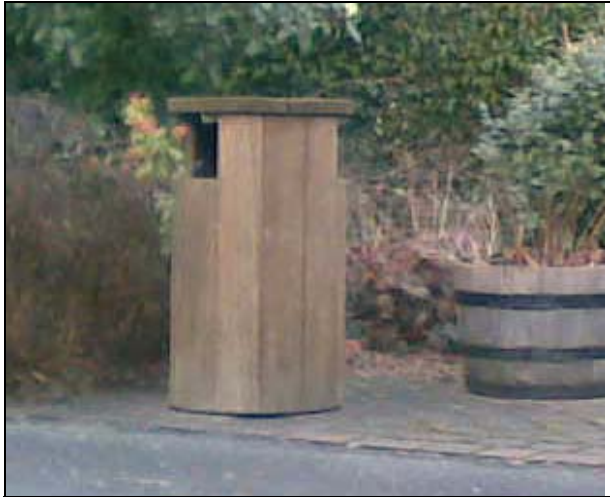
FIGURE 75. THIRD STYLE OF BIN DESIGN

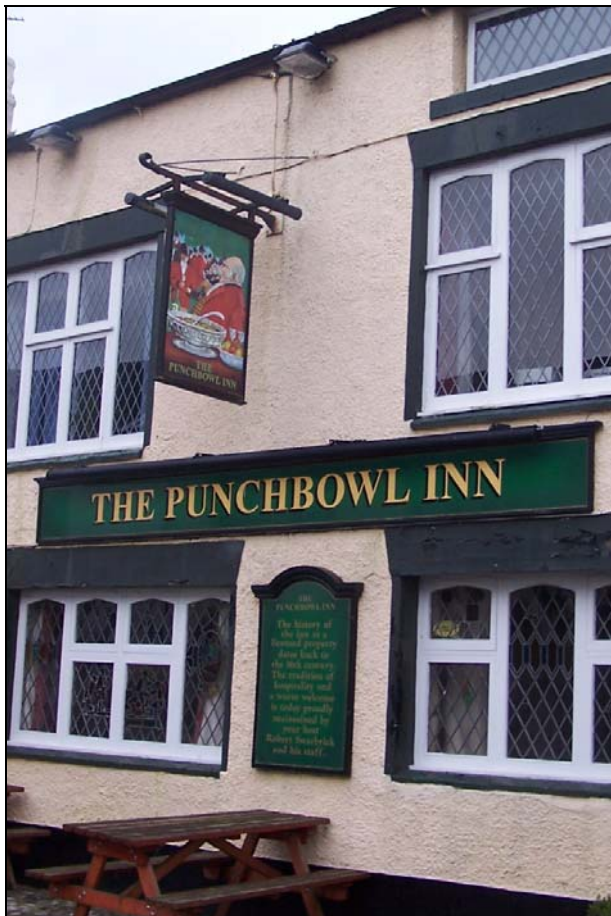
Signage is found within Churchtown Conservation Area relating to the two pubs, The Punch Bowl Inn and The Horns Inn. Examples of these advertisements are shown in Figures 76 and 77 respectively. These signs are appropriate for their location as they are constructed in fairly traditional design and materials.

FIGURE 76. THE PUNCH BOWL INN SIGNAGE

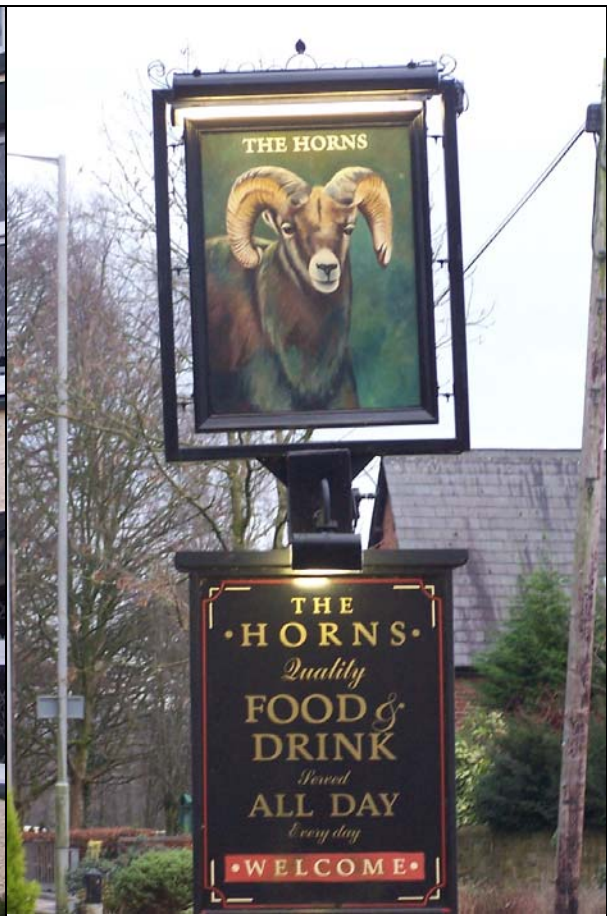
FIGURE 77. THE HORNS INN SIGNAGE

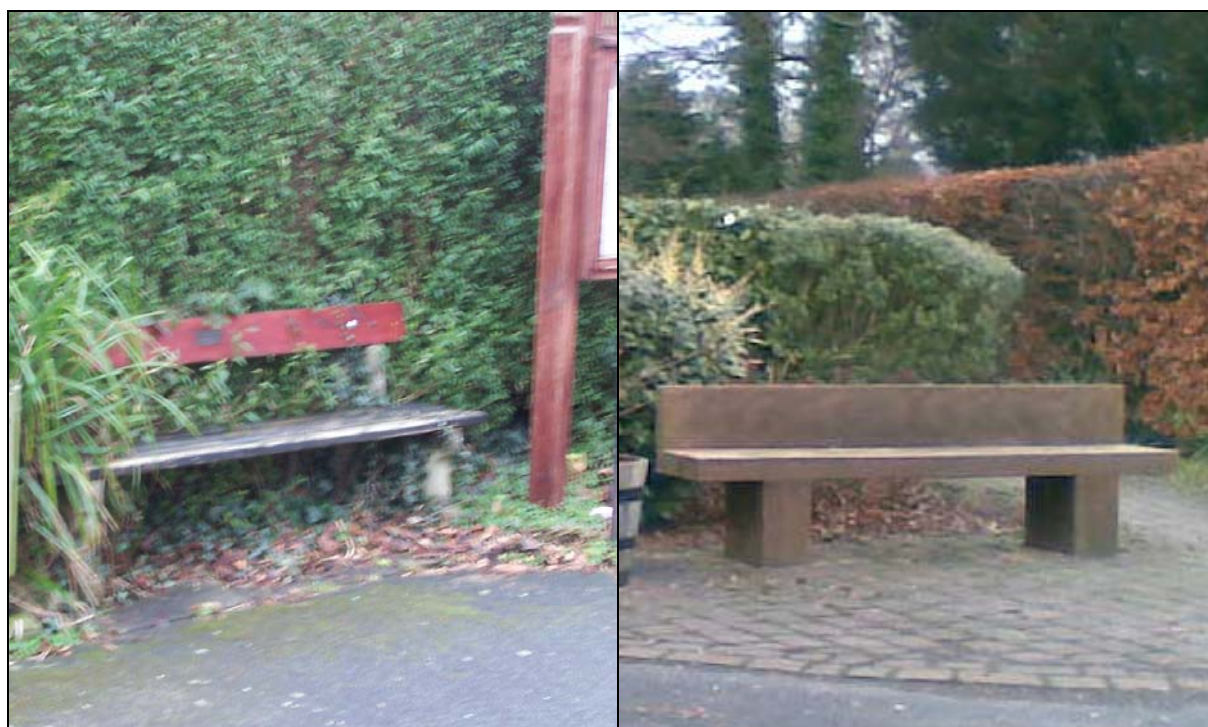
FIGURE 78. ONE DESIGN OF BENCH

Within Churchtown Conservation Area there are two styles of benches as well as differing materials in use. This can cause discontinuity and can attract attention away from the historic character and appearance of the Conservation Area. Consequently, to avoid attention being drawn to the incongruity of these features, these benches should be replaced at some point in the future in favour of one appropriate design and in appropriate materials, and consequently will aid in bringing continuity back into the area.

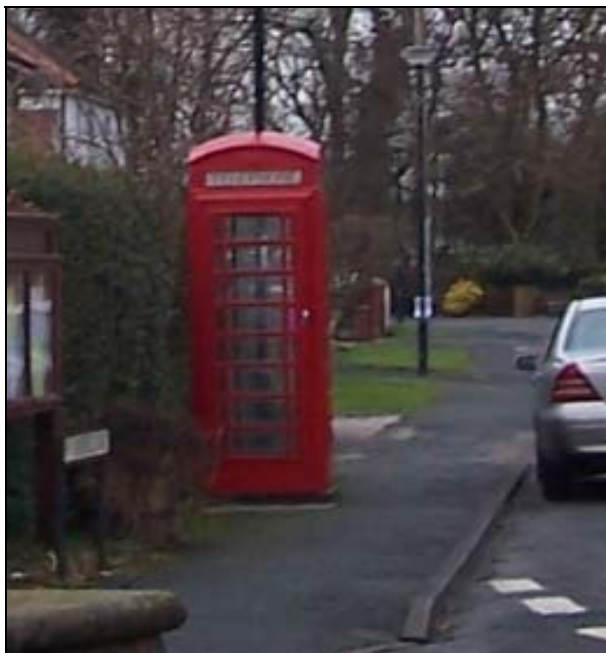
FIGURE 80. K6 STYLE OF TELEPHONE BOX

Within the Conservation Area boundary, there is only one public telephone box, being a K6 style public telephone box, which is Grade II Listed, as previously discussed in Section 4.3. This type of telephone box is highly desirable within a Conservation Area, is therefore of significant value and enhances the area considerably.

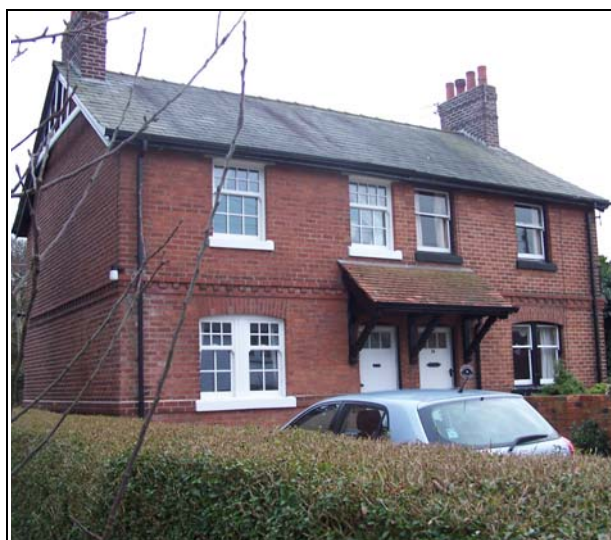
The majority of buildings within Churchtown Conservation Area are residential and as such there are few buildings commercial use. The more historical buildings are generally two-storey, semi-detached, and constructed of brick or natural stone, occasionally with diminishing slate courses (this is a term which applies to slates

FIGURE 83. TRADITIONAL TWO STOREY SEMI-DETACHED BRICK PROPERTIES

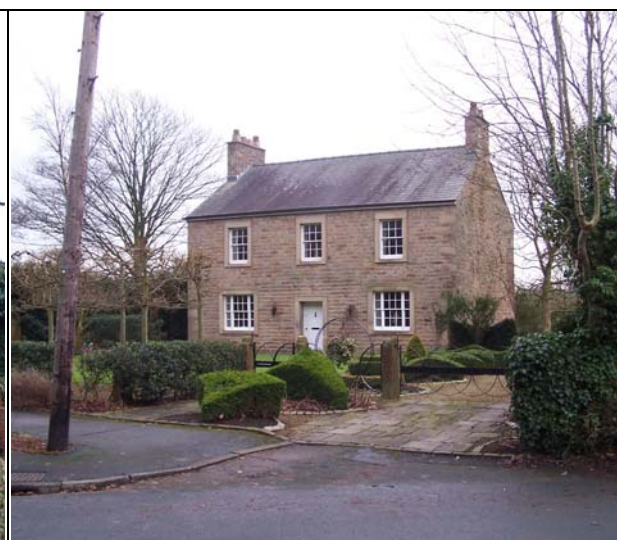
FIGURE 84. TRADITIONAL NATURAL STONE BUILDING

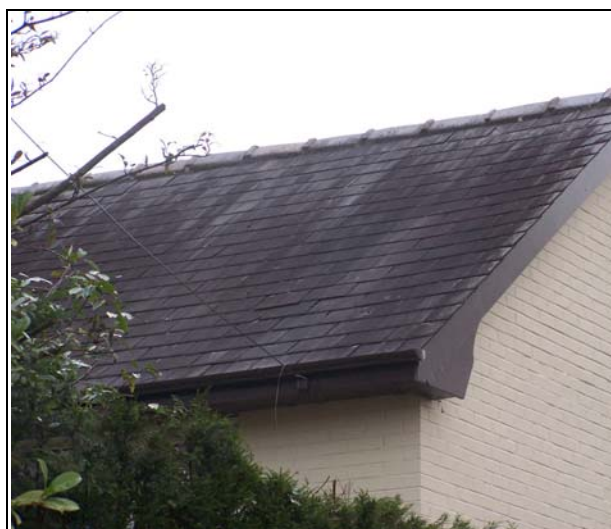
where the size of the slate decreases towards the ridge (University of Dundee, 2008)), as shown in Figures 83 to 85, while some of the more modern buildings are generally rendered or whitewashed with slate or tiled roofs (shown in Figures 86 to 87) and two or three storeys in height. However, there is some more modern development within the Conservation Area, generally from dating around the 60s, which, in the most part, has not been constructed of materials in keeping with the traditional and historical character of the area. However, it can be said that these allow the evolution of the village to be shown, as illustrated in Figure 88.

FIGURE 85. NATURAL SLATE ROOF

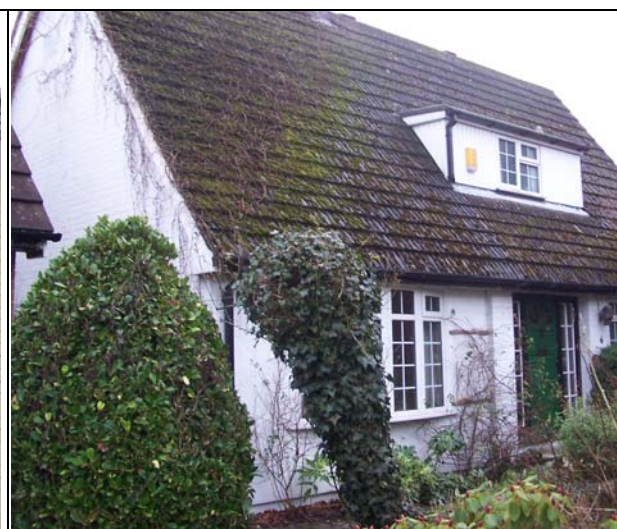
FIGURE 86. MODERN RENDERED / WHITEWASHED PROPERTY

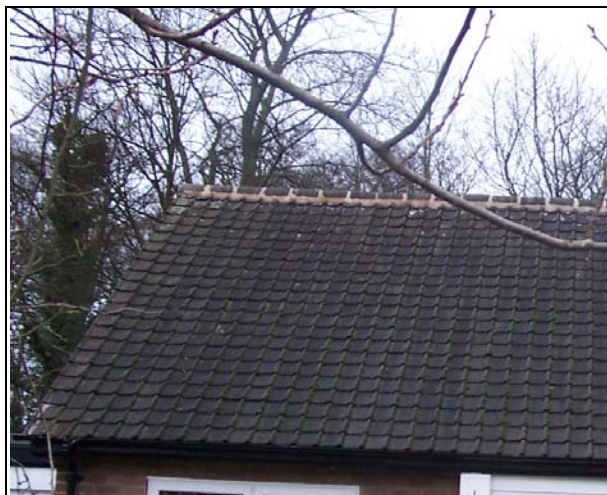
FIGURE 87. MODERN CONCRETE TILE ROOF

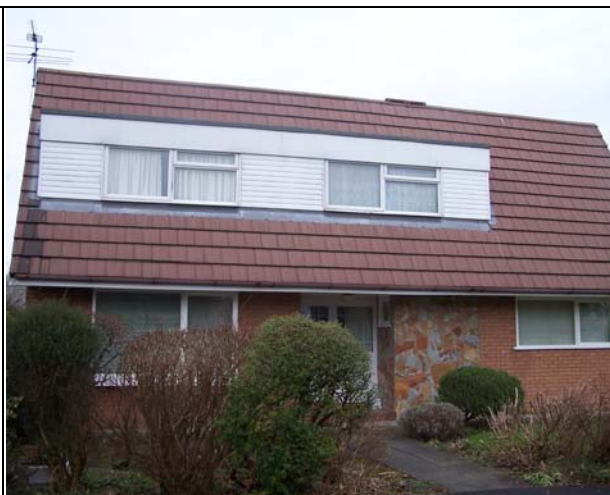
FIGURE 88. MORE MODERN BUILDING STYLE
