Churchtown Conservation Area Appraisal and Management Plan

Churchtown Conservation Area Appraisal

Wyre Borough Council

Adopted 19th July 2010

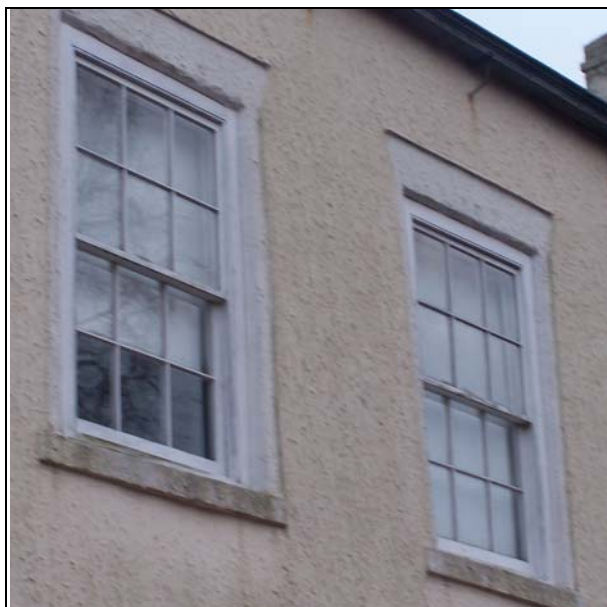
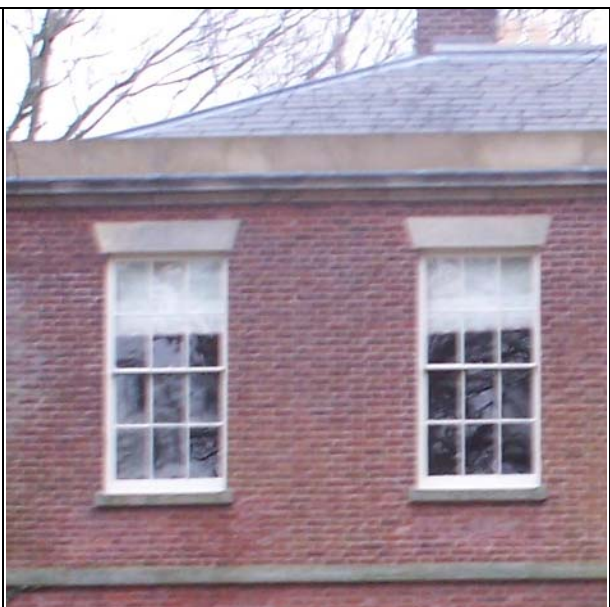
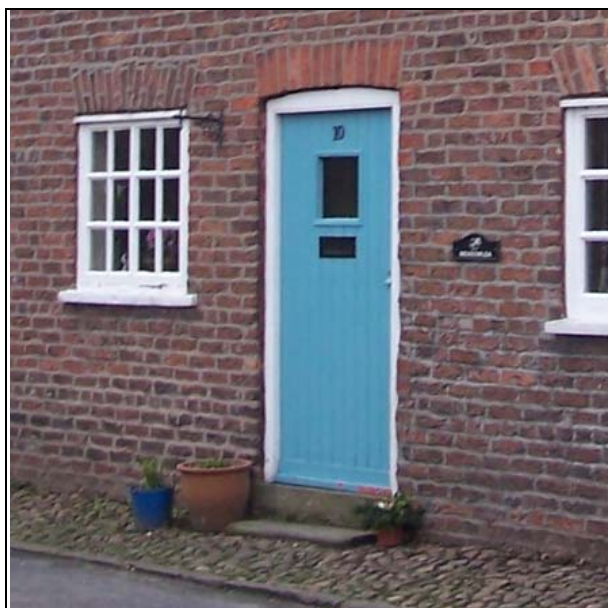
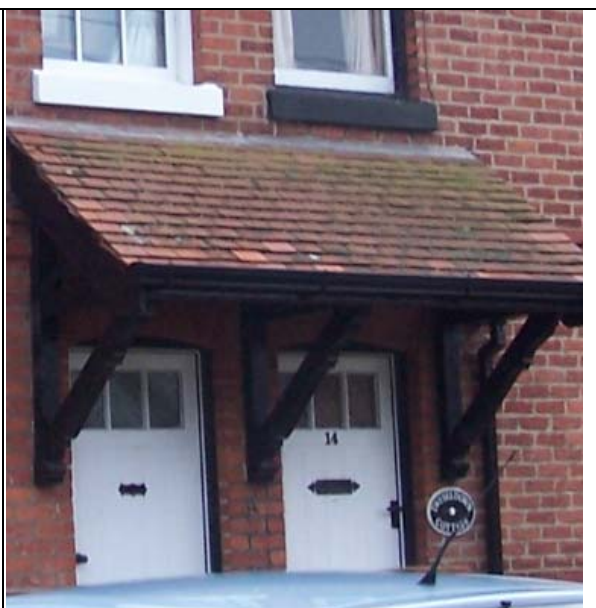
Windows and doors would originally have been recessed and constructed of timber, with a paint finish, in a sash and casement design. However, due to the attraction of modern uPVC glazing, which is more readily available and relatively cheap by comparison to traditional timber, many of these traditional windows have been lost, as well as many original timber doors. UPVC use is detailed further in section 5.2 Issues and Threats. These traditional features do, however, tend to remain in Listed Buildings due to protective legislation. Examples of these differing window and door materials and designs can be seen in Figures 88 – 93.

FIGURE 89. SASH AND CASEMENT WINDOWS

FIGURE 90. TIMBER SASH AND CASEMENT WINDOWS

FIGURE 91. TRADITIONAL TIMBER DOORWAY

FIGURE 92. TRADITIONAL PAINTED DOORS

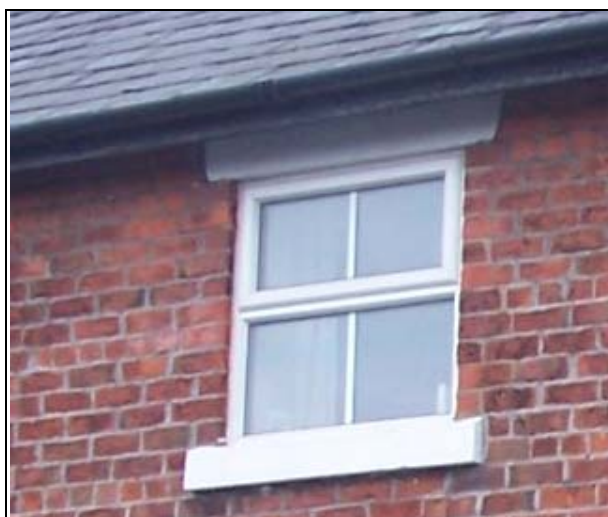
FIGURE 93. MODERN UPVC WINDOWS

Within Churchtown Conservation Area, more timber sash and casement windows are being replaced with uPVC. UPVC is a modern material, and as such should be discouraged as inappropriate and incongruous within Conservation Areas as standard. Timber is a traditional material and consequently should be promoted in all circumstances. Good examples where timber sash and casement windows remain in situ are illustrated in Figures 95 and 96. Figure 97 shows appropriate timber sash and casement window, while Figure 98 illustrates inappropriate uPVC windows.

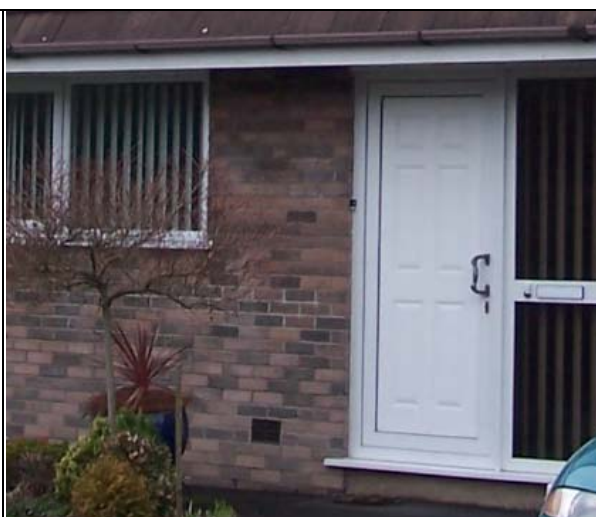
FIGURE 94. MODERN UPVC DOOR

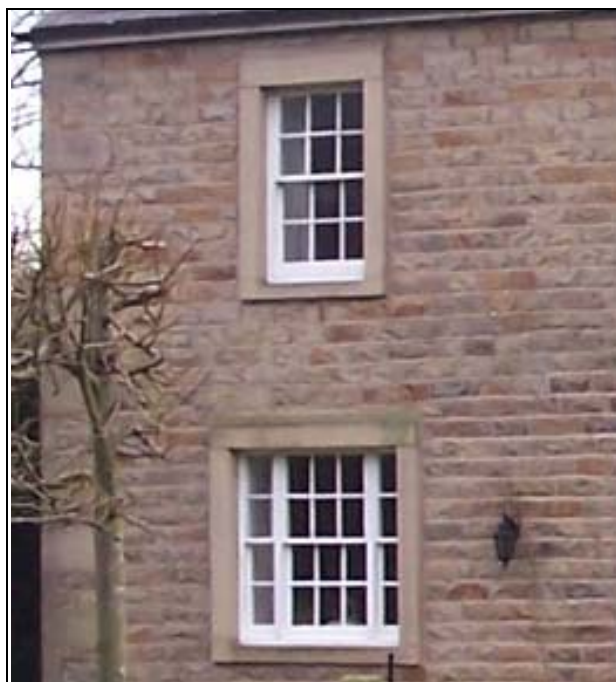
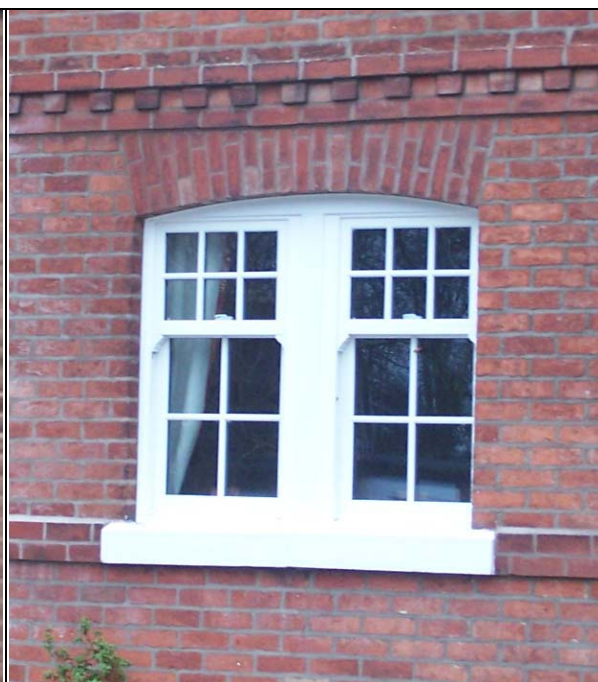
FIGURE 95. GOOD EXAMPLE OF SASH AND CASEMENT WINDOWS

FIGURE 96. GOOD EXAMPLE OF A SASH AND CASEMENT WINDOWS

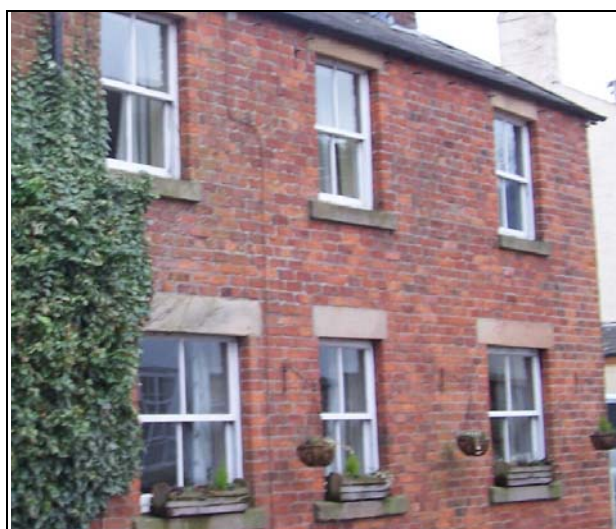
FIGURE 97. APPROPRIATE SASH AND CASEMENT WINDOWS

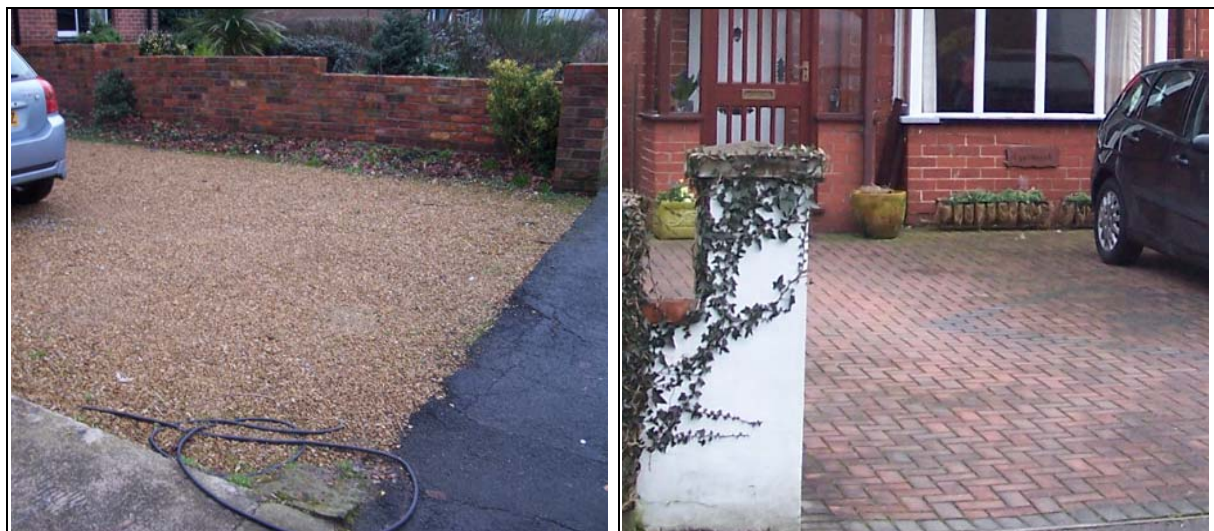
for the future, but all current impermeable hardstanding areas will continue to be an issue until their replacement. Consequently this is a negative factor not only with regard to the character and appearance of the Conservation Area, but also the wider environment as a whole.

FIGURE 99. FRONT GARDEN LOST IN FAVOUR OF OFF STREET PARKING, LIABLE TO INCREASE FLOODING

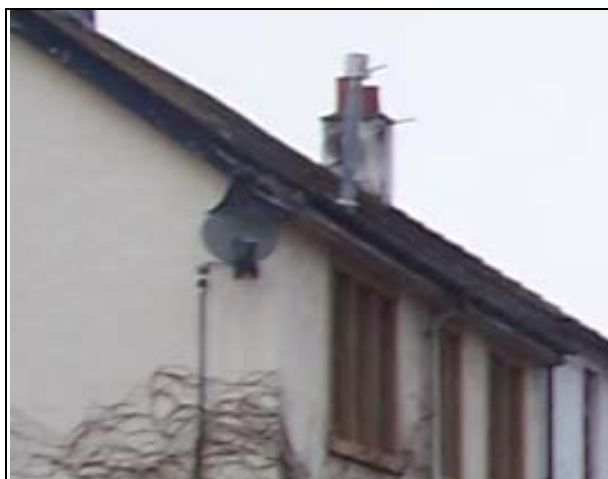
A further threat to the character and appearance of Churchtown Conservation Area is the increasing appearance of satellite dishes on the front elevation of properties. Often an unknown fact is that the siting of a satellite dish on the chimneystack or on the roof slope or elevation fronting a road requires Planning Permission from the Council. This does not mean, however, that satellite dishes are prohibited within a Conservation Area, they are simply encouraged to be placed out of view, on the rear of properties if feasible. Examples where satellite dishes have been placed on inappropriate elevations are illustrated in Figures 101 and 102. This is likely to be the result of being unaware of the rules that surround Conservation Areas. Appendix 7.4 details the effect of Conservation Area designation.

FIGURE 101. INAPPROPRIATELY PLACED SATELLITE DISH

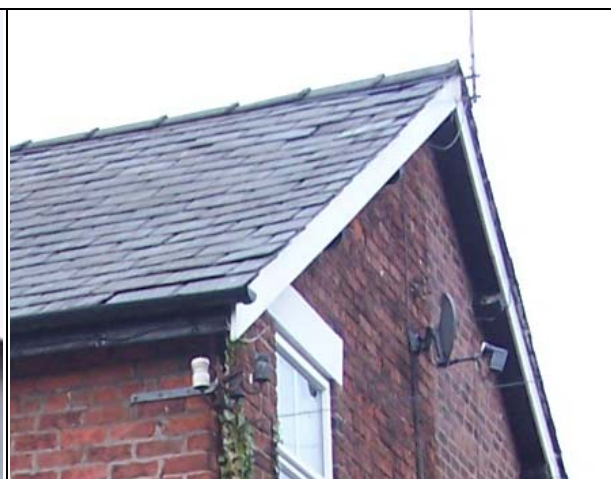
FIGURE 102. INAPPROPRIATELY PLACED SATELLITE DISH

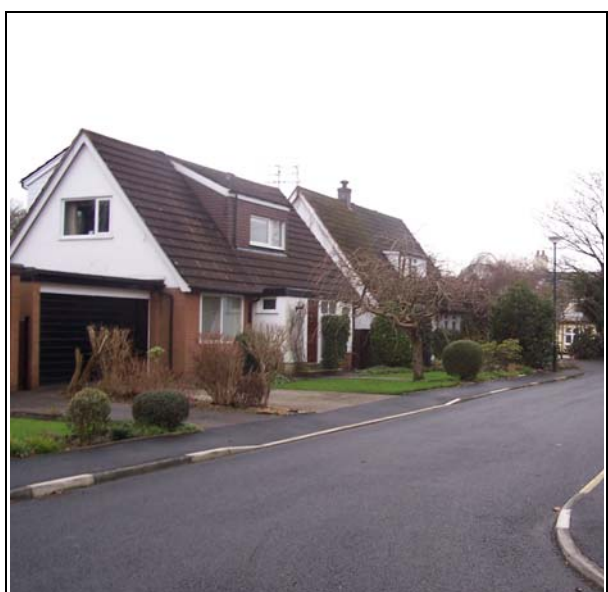
The buildings within a Conservation Area are constantly evolving to keep up with modern requirements and trends. Although this is not discouraged, it is essential for the character and appearance of the Conservation Area, that any changes or alterations to buildings are completed with respect for the historic surroundings. One example of where this has not happened, possibly to the detriment of the Conservation Area, is in St. Helen's Close and Kingsacre, illustrated in Figures 103 and 104 respectively. However, although these buildings are not particularly in keeping with the historical and architectural interest of the area, it can be argued that these buildings give a good example of the evolution of the village and the changes that have occurred in architectural styles.

FIGURE 103. ST HELEN'S CLOSE DEVELOPMENT

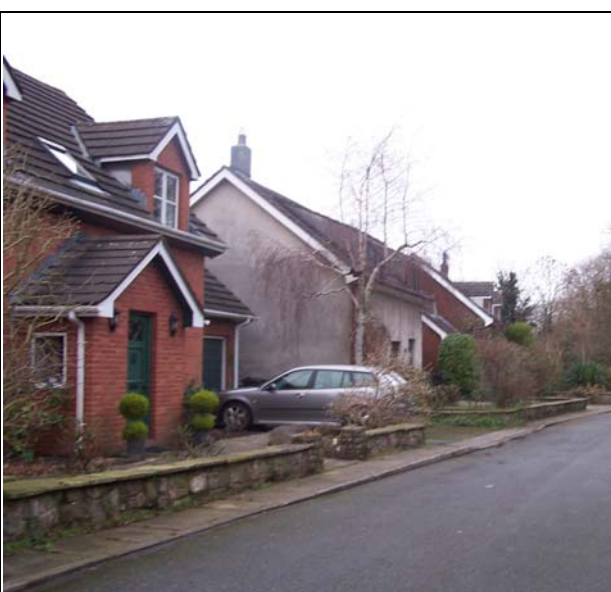
FIGURE 104. KINGSACRE DEVELOPMENT
