Garstang Conservation Area Appraisal and Management Plan

Garstang Conservation Area Appraisal

Wyre Borough Council

Adopted 19th July 2010

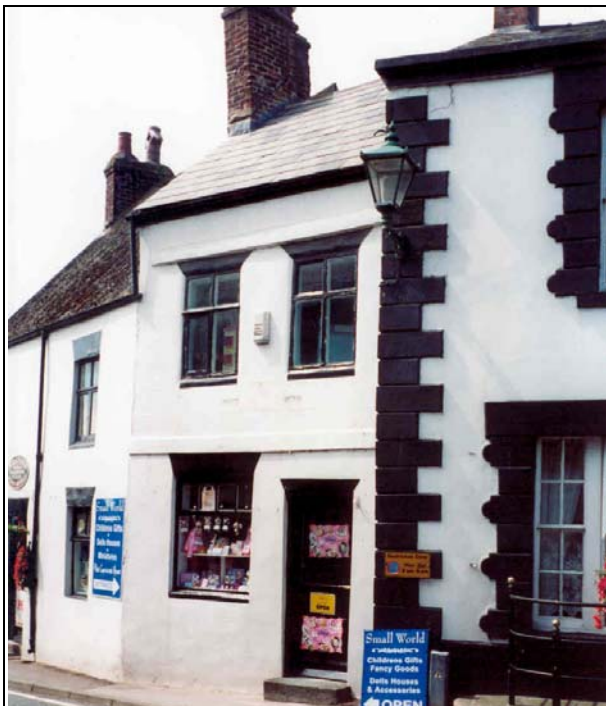
This shop, listed on 9th January 1986, dates from around the mid eighteenth century, although has some alteration. It is rendered, with a brick chimney to the left, and of two storeys with two bays. The windows are of fairly modern design with rendered reveals, as does the door, situated in the right-hand bay.

FIGURE 19. 2 BRIDGE STREET

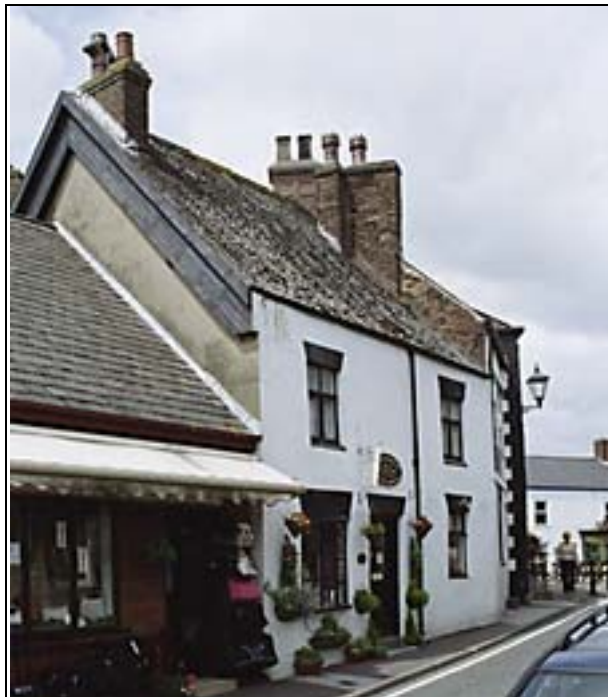
Also a shop, this property was listed on 17th April 1967, and is thought to date from the mid to late eighteenth Century. It is also rendered with a brick chimney, though has a corrugated sheet roof that would have replaced thatch. It is of two bays with

the door set between, and has modern windows and door, though both have rendered reveals.

FIGURE 21. 4 BRIDGE STREET

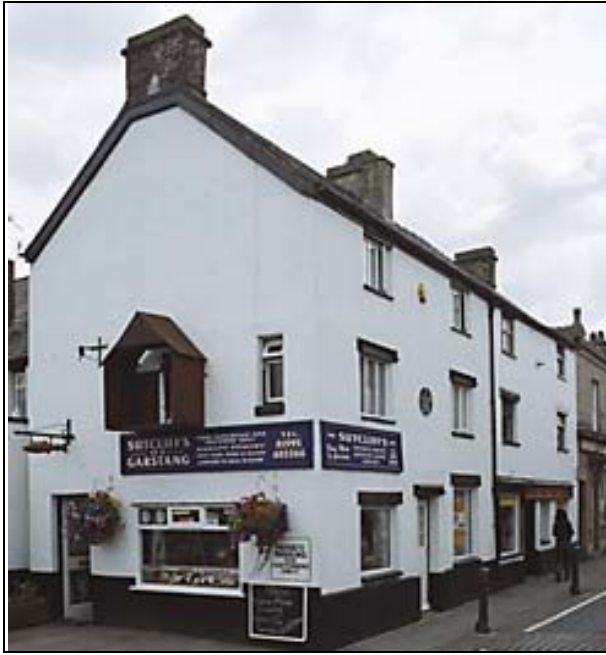
These three shops dating from 1741 were also listed on 17th April 1967, and are of three storeys with four bays, though have been altered. Two doors, one situated between third and fourth bays, and the second is located between the first and second bays, above which is a plaque inscribed: 'EMG 1741 JG'.

FIGURE 23. 11, 12 AND 13 BRIDGE STREET

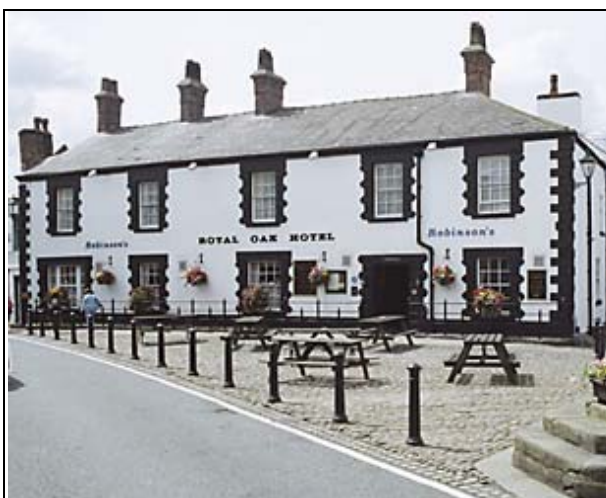
Listed on 17th April 1967, this nineteenth century public house is rendered with sandstone quoins, a slate roof, hipped at the right, and four brick chimneys. It is of two storeys and five bays, with sash and casement windows, which have glazing bars in a vertical ‘six over six’ arrangement and painted rusticated surrounds. It forms a focal point at the southern end of High Street, and has an area of outside benching on setts, which add to the ‘market town’ character of the area as a whole. Set at the end of this outdoor benching area sits a scheduled monument, of which this Appraisal details further in section 4.4.

FIGURE 25. ROYAL OAK HOTEL, BRIDGE STREET

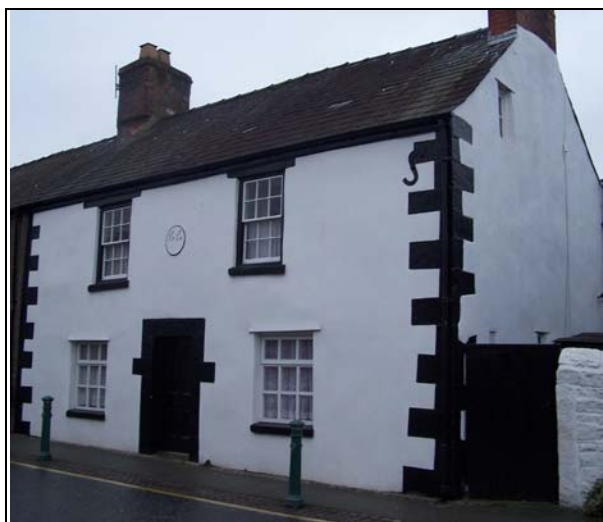
FIGURE 27. 43 HIGH STREET

Dating from 1744, this house and shop was listed on 17th April 1967. It is constructed of slobbered rubble, with a slate roof and brick chimneys, and is of two storeys and two bays. First floor windows are sash and casement with glazing bars in a vertical 'six over six' arrangement, while ground floor windows appear to be of modern origin. The door is situated between bays and above, written on an oval plaque, is the inscription: 'JG 1744'.

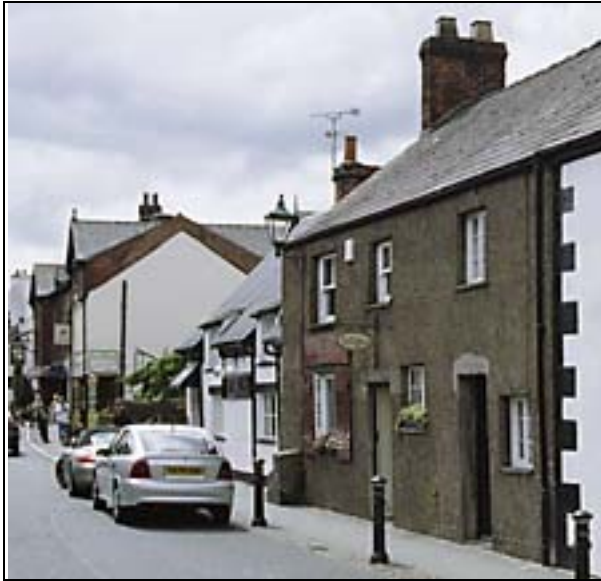
FIGURE 29. 44 AND 45 HIGH STREET

This house and shop was listed on 15th October 1970, and dates from the late eighteenth century. It is constructed of a rubble build and pebbledashed with a slate roof and two brick chimneys. Number 44 has horizontal sash and casement windows, with glazing bars in a 'three over three' arrangement. Number 45 has a modern shop window at ground level and the first floor windows are sash and casement. Attached to the wall of Number 45 is a mounting block which forms three steps, and has inscribed on the front: 'RRA 1685'.

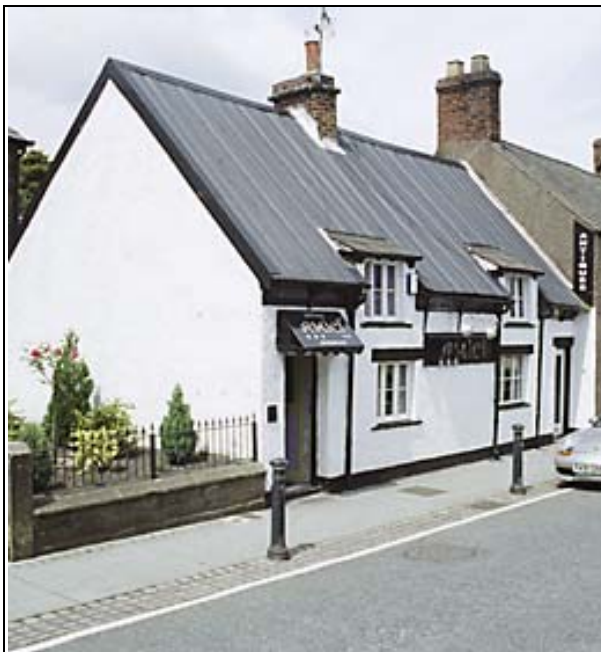
Thought to be dating from the early 18th Century, this building, now in use as a café, was listed on 15th October 1970. Constructed of rubble, the property is of one storey, with attic dormers, and two bays. The steep corrugated iron roof is thought to have replaced thatch at some point in the near past. The windows are of three lights with timber mullions with the exception of the right-hand ground floor window, which is of modern origin. The two properties are basically mirror images of the other, although modern alterations have occurred independently.

FIGURE 31. 46 AND 47 HIGH STREET

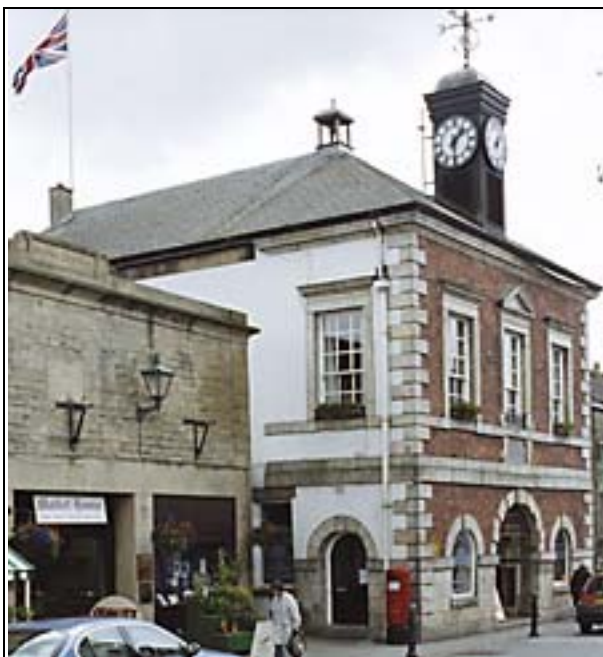
This building, previously the Town Hall and now in use as shops and a club was listed on 16th December 1952, and dates from 1755-64. It is constructed of brick with sandstone dressings and has a hipped slate roof. It is of two storeys with three bays. The ground floor has three rounded arches linked through banding. The outer of these arches are now windows, and the wide central arch is used as an entrance. The windows to the first floor are sash and casement with glazing bars in a vertical 'nine over six' arrangement, and are linked by a sill band. Above the central bay, on the roof, is a timber cupola with clock.

FIGURE 33. MARKET HOUSE, HIGH STREET

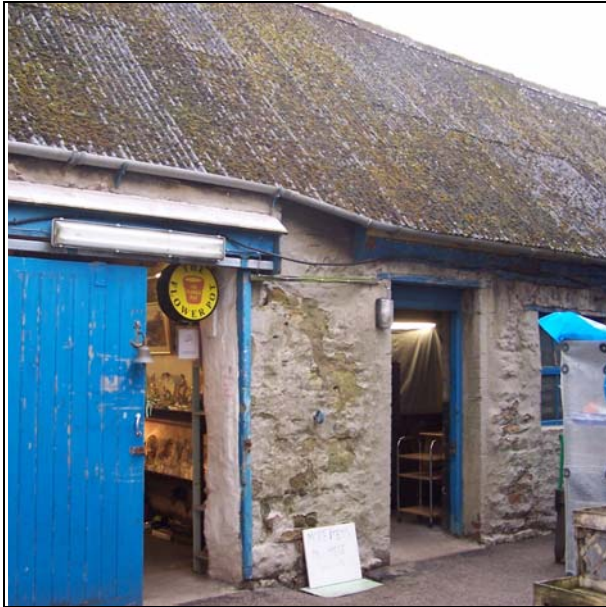
Listed on 9th January 1986, this store building was once used as a slaughterhouse and dates from around the seventeenth century, though has been altered. It is cruck framed with sandstone rubble walls, with a steep roof made of corrugated asbestos. At the left side of the building there is a wide opening with an external sliding door, and at the right there is a door, which has a windows to its right. At the far right of the building there is a further door, which is covered by a wooden lean-to.

FIGURE 35. OUTBUILDING BEHIND MARKET HOUSE, HIGH STREET

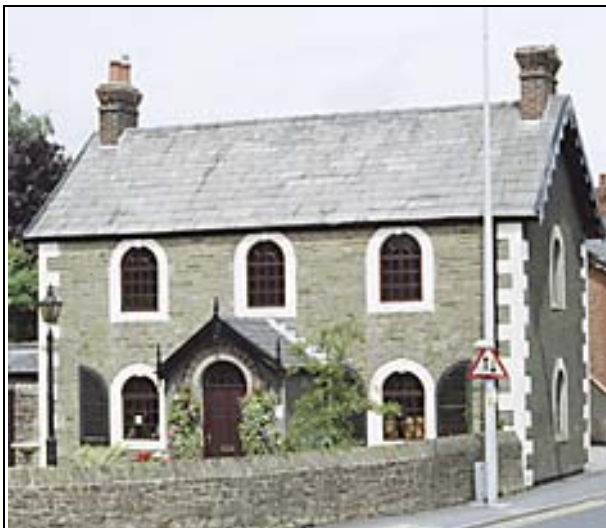
FIGURE 37. ARTS CENTRE, LANCASTER ROAD

The Arts Centre, which was formerly a school dates from the late eighteenth century and was also listed on 9th January 1986. It is constructed of sandstone rubble, with projecting quoins, with a slate roof and two brick chimneys. It is of two storeys with three bays, with a single storey gabled porch in the central bay with an entrance door. All windows have glazing bars and stone surrounds, with curved lintels. In addition, the ground floor windows have external wooden shutters.

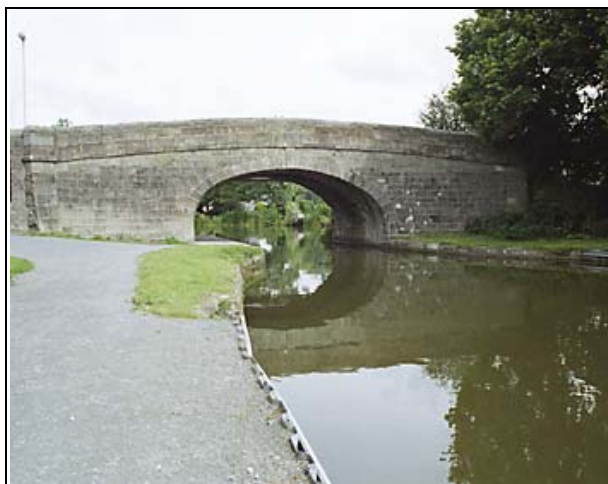
FIGURE 39. CANAL BRIDGE (NO. 62)

Listed on 13th April 1978, this bridge over the Lancaster Canal was opened in 1797 and designed by engineer John Rennie. It is constructed of sandstone blocks with one elliptical arch.

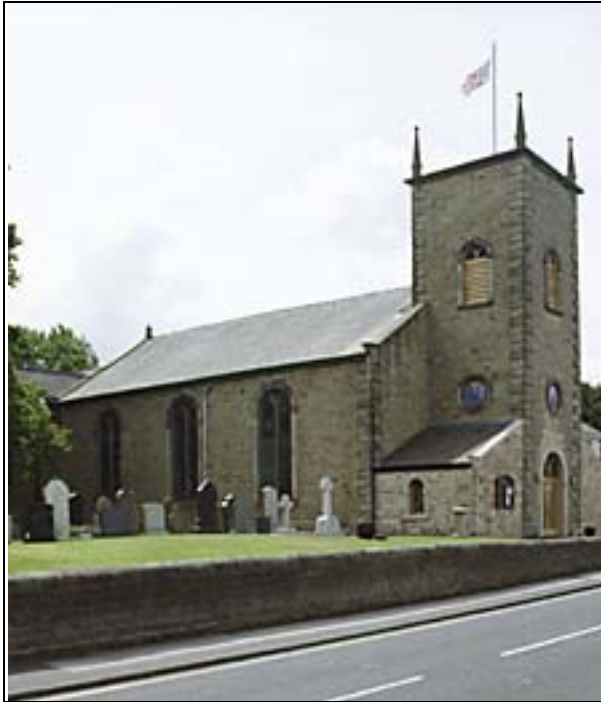
Richard Gillow built this church, listed on 17th April 1967, in 1770, with the chancel being added in 1876. It is constructed of sandstone rubble with slate roof and comprises of a west tower, nave and lower chancel with north transept. The tower and nave have quoins, and the bell openings have plain stone surrounds with round heads. Below each of the three bell openings is an oculus with a plain stone surround, which is similar to the surrounds of the north and south doors. The nave is of three bays and the three windows on each side are similar in style and design to the bell openings though on a much taller scale. These tall windows have a central timber mullion which branches to form a Y-tracery, which may be a later alteration. The interior has a west gallery with a panelled front situated on two slim iron columns. The nave has a ribbed ceiling that conceals the upper parts of the roof trusses, while the chancel arch is rounded with a plastered finish.

FIGURE 41. CHURCH OF ST THOMAS

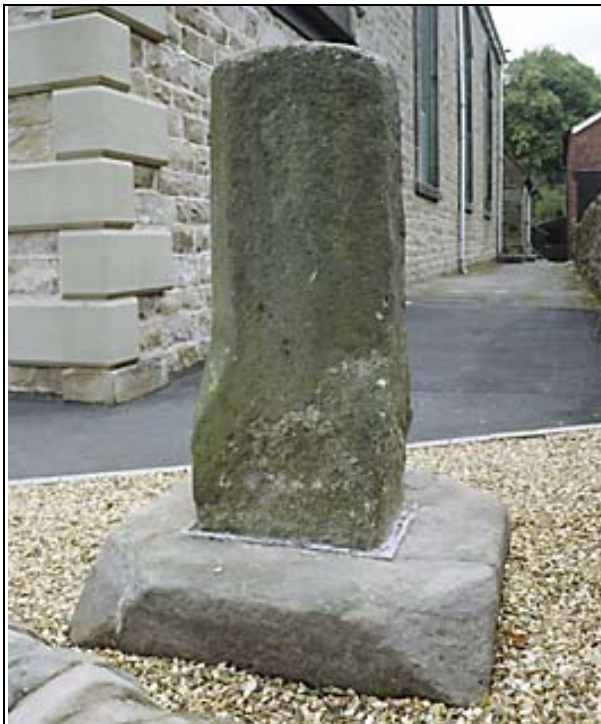
Listed on 9th January 1986, this cross base is thought to be medieval in date and is constructed of sandstone. The base is roughly rectangular with a rectangular shaft inserted within.

FIGURE 43. CROSS BASE

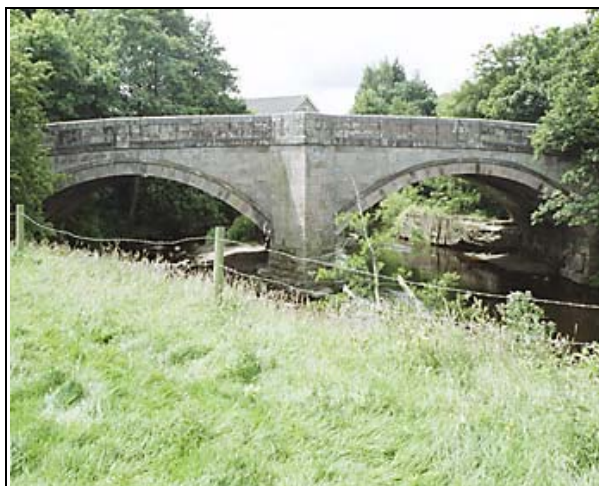
FIGURE 45. GARSTANG BRIDGE

This bridge dates from the early nineteenth century and was listed on 16th December 1952. There is evidence that it was widened on the east side in the twentieth century. The bridge is constructed of sandstone with two segmental arches.

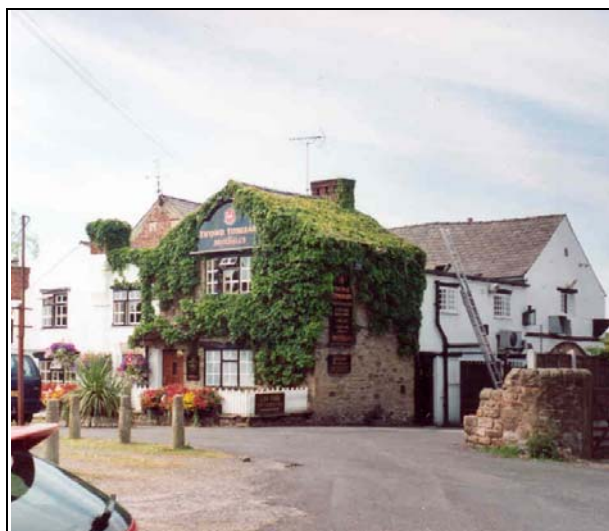
FIGURE 54. LABURNUM COTTAGE, HIGH STREET

As well as these, two buildings from the Local list have been suggested to English Heritage in the past for Spot Listing but have failed in this application. These buildings are as follows: Laburnum Cottage, High Street and 3 High Street, and can be seen in Figures 54 and 57 respectively.

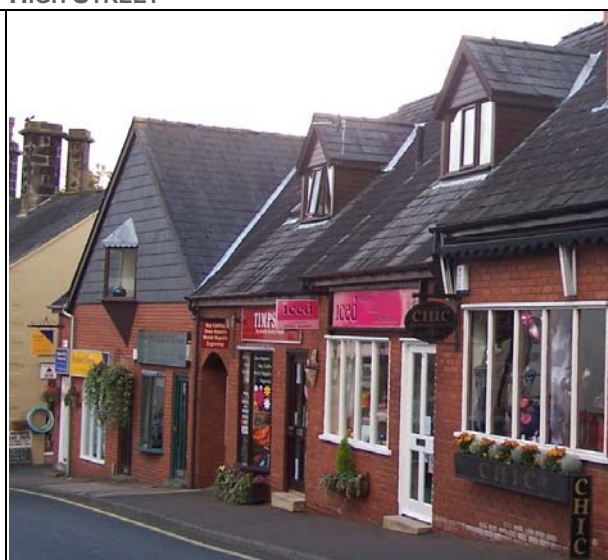
FIGURE 58. 8-12 BRIDGE STREET (EVEN)

Of these locally listed buildings, four were initially listed at Grade III, but were de-listed in the 1970s when Grade III Listed Buildings were abolished, leaving Grades I, II* and II. These buildings are 81-85 Church Street; 70-72 Church Street; 63-67 Church Street; and 8-12 (even) Bridge Street, as can be seen in Figures 49, 52, 53, and 58 respectively.

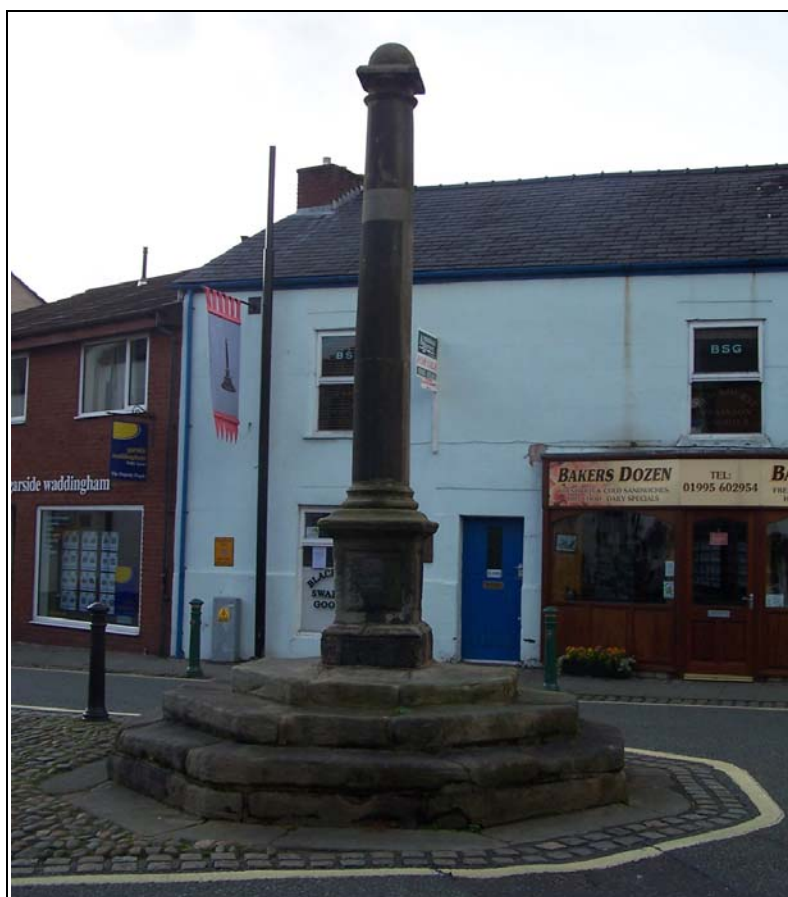
There is one scheduled monument within Garstang Conservation Area, namely the Market Cross, on High Street. Alterations have occurred over the years however, being that the cross shaft of this scheduled monument appears to have been replaced in the eighteenth century and the structure was rebuilt in 1897 to celebrate Queen Victoria's Jubilee (LCC, 2006).

FIGURE 59. GARSTANG MARKET CROSS

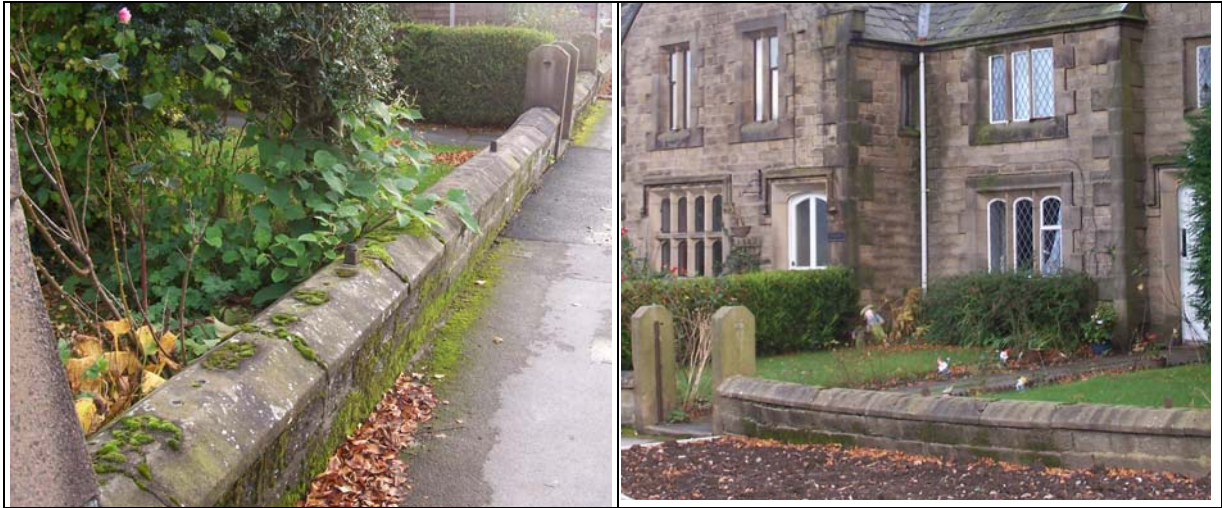
Boundary walls are not a common feature within the majority of properties within Garstang due to their commercial nature. However, there are a few good examples of where boundary walls have been retained, as can be seen in Figure 60 and 61.

FIGURE 60. BOUNDARY WALLS ON CHURCH STREET FIGURE 61. BOUNDARY WALLS

Boundary walls, where they exist, are important features of a Conservation Area in that they illustrate the curtilage of each property, rather than as a means to prevent unwanted access. Where boundary walls are found in situ in front of a group of buildings, they create harmony and homogeneity, in a similar way to slate roofs and timber sash and casement windows, and it is these reasons that their retention is important with a view to the character and appearance of the Conservation Area.

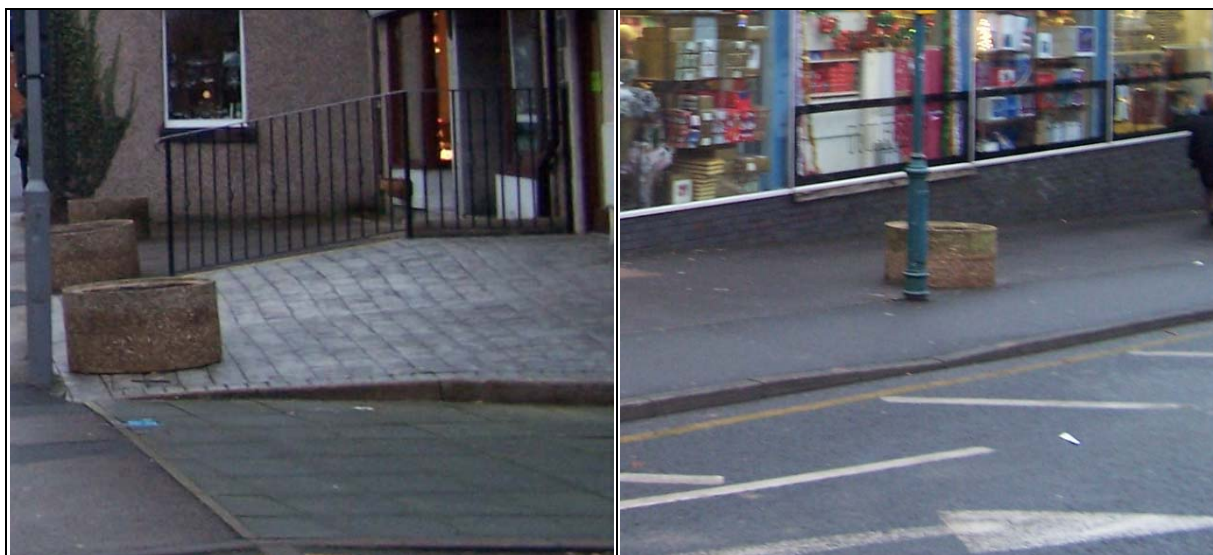
Where boundary walls have been removed, incongruous open areas are created, that generally do not fit in with their surroundings, as illustrated in Figures 62 and 63. In more recent years, this has seemingly been done in residential areas to allow for off-road parking.

FIGURE 62. FORMER RESIDENTIAL NOW COMMERCIAL BUILDINGS WITH BOUNDARY WALLS REMOVED

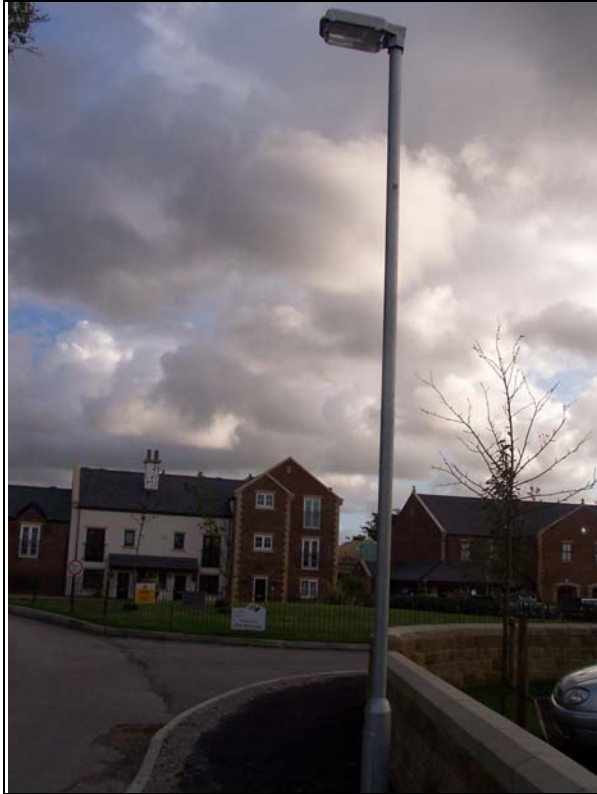
FIGURE 64. INAPPROPRIATE MODERN STREETLIGHT

- Three styles of street lighting, one of which is appropriate and should consequently replace the two other inappropriate styles in the future;
- Numerous materials used in street surfacing, with cobbles, setts, concrete and tarmac being most common;
- Two designs of litter bins within the area, which should, in the future, be replaced for one single design;
- Grant scheme which has improved many shopfronts, however there is still an increasing use of inappropriate materials within the Conservation Area;
- Two designs of benches within the area, which should, in the future, be replaced for one single design; and
- Two designs of telephone boxes within the Conservation Area, with the red K6 style enhancing the area and the more modern design neither detracting nor enhancing the area.

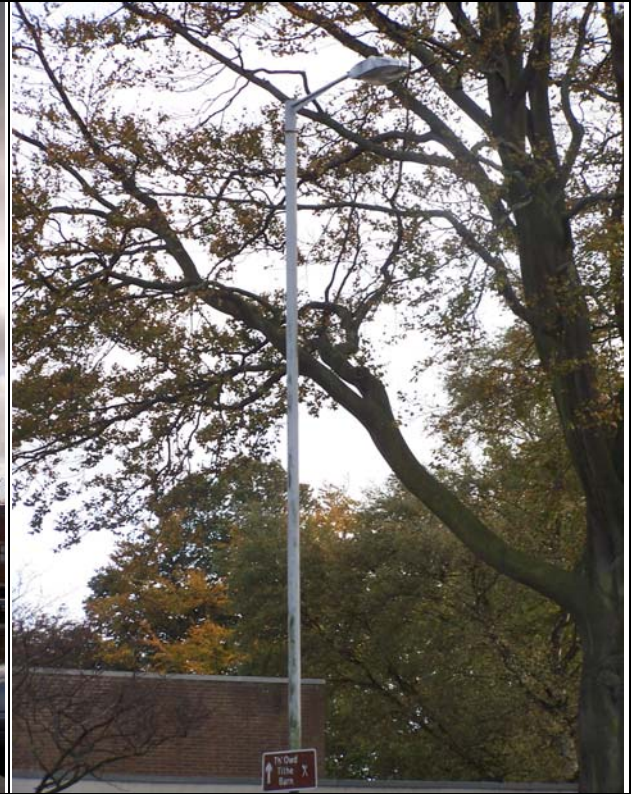
FIGURE 65. INAPPROPRIATE MODERN STREETLIGHT

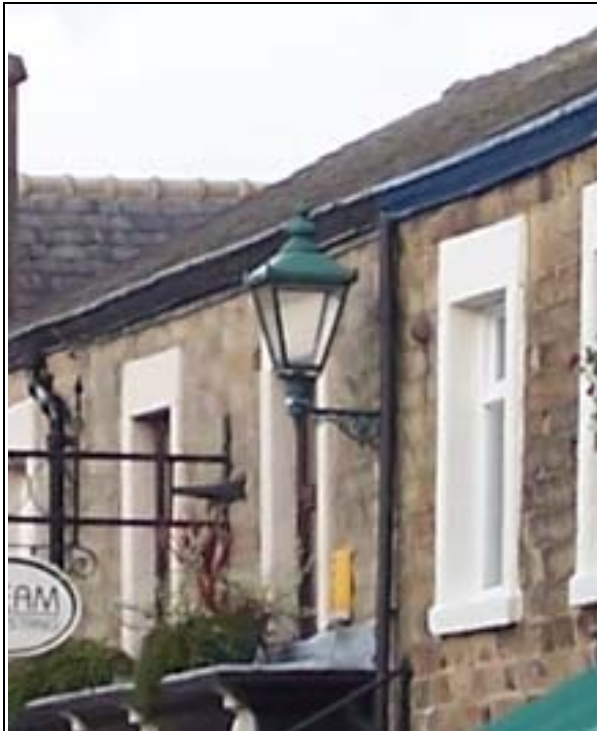
Within Garstang Conservation Area, there are three different designs of street lighting, some examples of which are shown in Figures 64 – 66. Figures 66 and 67 illustrate one of the three styles of lighting, showing both a wall mounted and a freestanding streetlight, both of which has a traditional design. This is consequently considered more appropriate for the historic character and appearance of the Conservation Area. It is essential to have continuity within a Conservation Area in

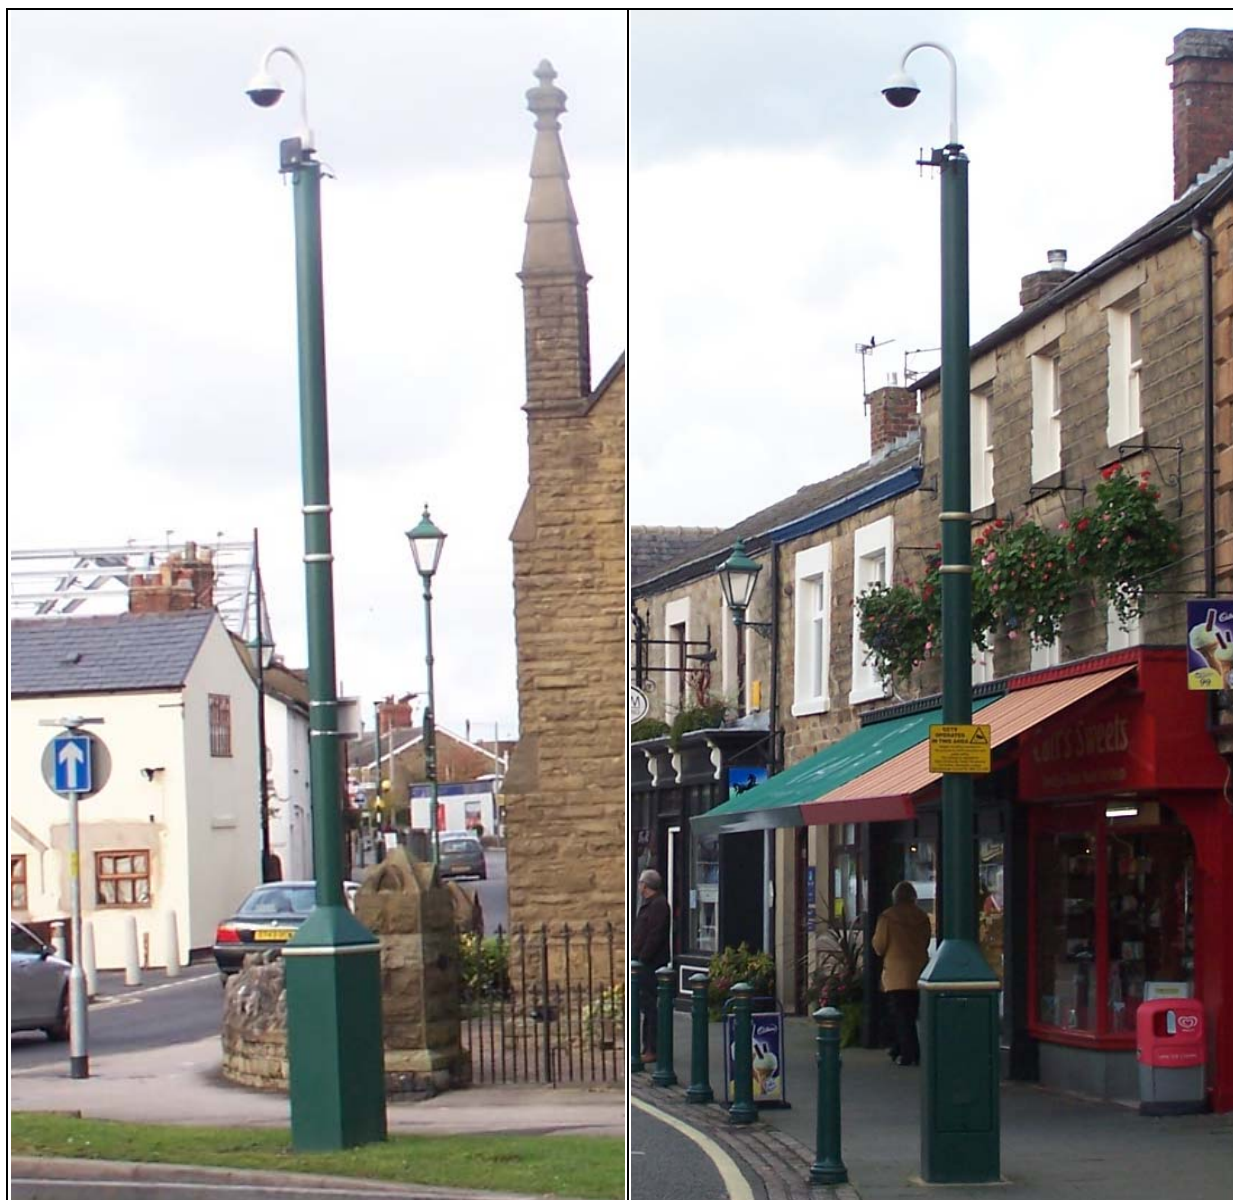
There are several CCTV camera columns located throughout the Conservation Area, though mainly located on Park Hill Road and High Street, in order to enforce public safety. They all appear to take the same fairly traditional unobtrusive design, as illustrated in Figures 68 and 69, vaguely similar to that of the traditional street lighting, and as such can be seen to have a neutral effect on the character and appearance of the Conservation Area.

FIGURE 68. CCTV CAMERA COLUMN DESIGN ON PARK HILL ROAD

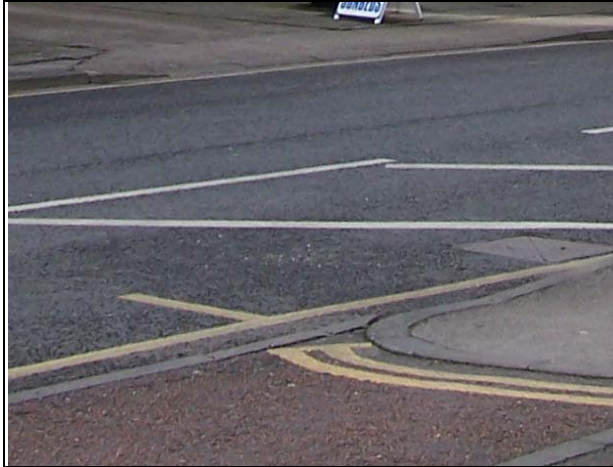
There are numerous different types of street surfacing within the Conservation Area; ranging from cobbles, to tarmac and concrete. Examples of these are illustrated in

FIGURE 70. THREE DIFFERENT TYPES OF SURFACING, BRIDGE STREET

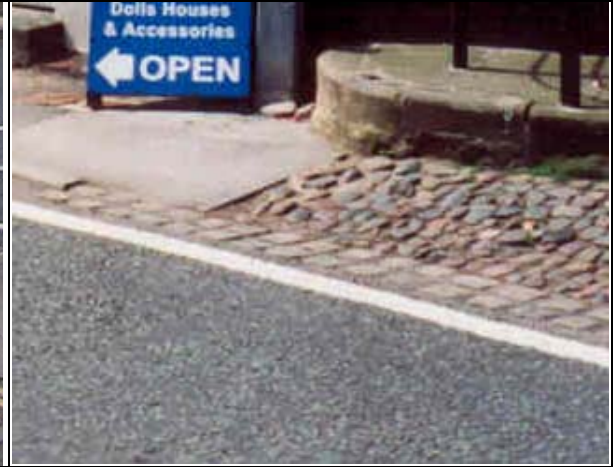
Figures 70 – 73. Pavement areas also range in material, being both cobbles in some areas and also concrete. This can be seen in Figures 68 and 69.

FIGURE 71. A CHANGE IN PAVEMENT MATERIAL FROM CONCRETE TO COBBLES, BRIDGE STREET

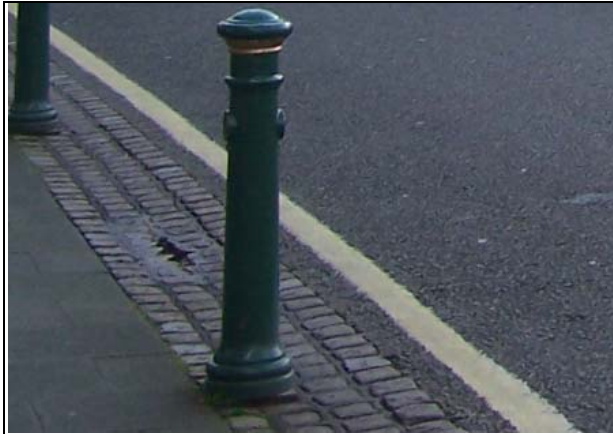
FIGURE 72. A CONCRETE PAVEMENT, SETS FOR THE GUTTER, AND A TARMAC ROAD, HIGH STREET

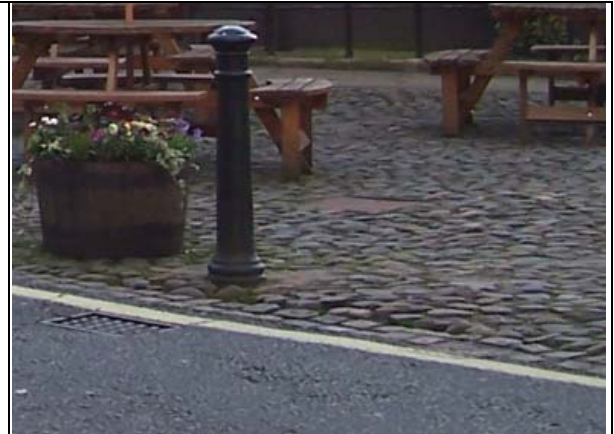
FIGURE 73. COBBLES IN THE MARKET PLACE, OUTSIDE ROYAL OAK HOTEL, HIGH STREET

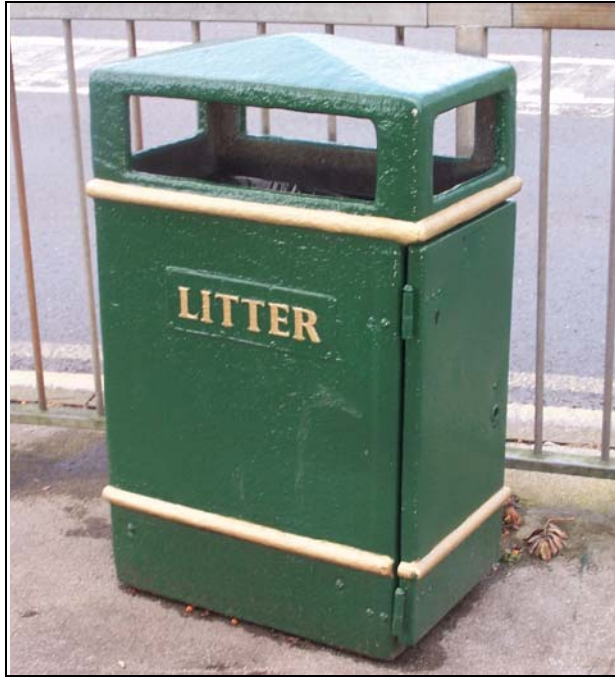
Within Garstang there are two styles of litterbin, as shown in Figures 74 and 75. Due to these differing designs and materials, attention is attracted away from the character of the Conservation Area. In order to ensure that this is prevented from occurring, one style should be chosen and uniformly used in all situations within Garstang, preferably the cast iron style.

FIGURE 74. CAST IRON BIN DESIGN

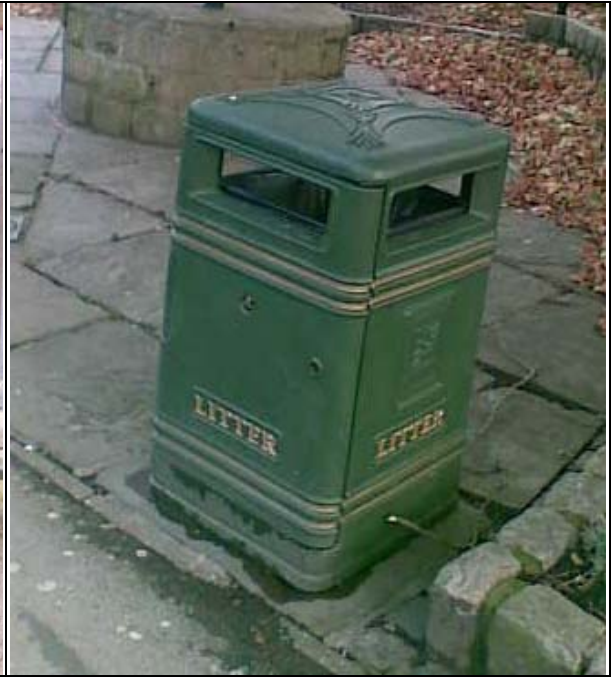
FIGURE 75. PLASTIC BIN DESIGN

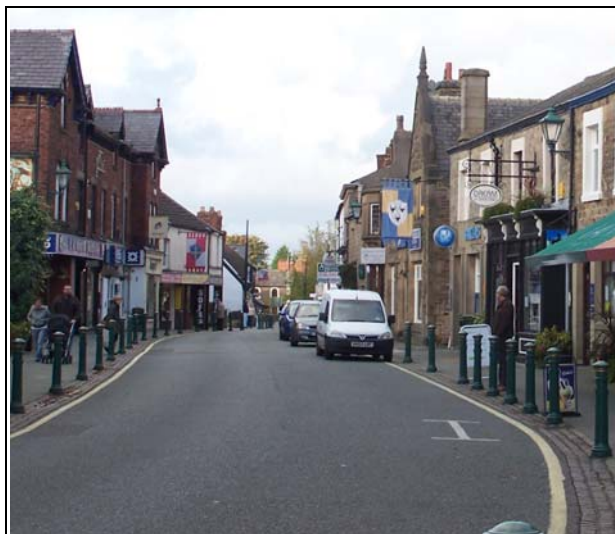
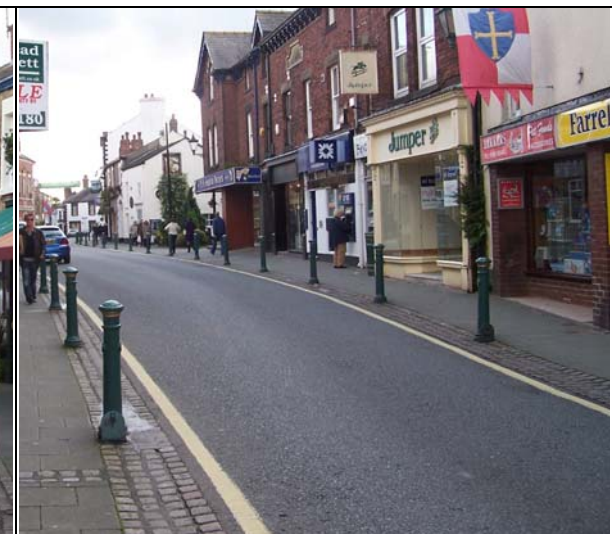
To ensure that the High Street is still accessible for vehicles and the pavement not used for parking, both sides of the road have bollards for the entire length, as can be seen in Figures 76 and 77. Although this does increase public safety, as the pavements, and therefore pedestrians, are protected from vehicles, it does have an effect on the character and appearance of the Conservation Area. However, as these features are all of the same design, colour and match other existing appropriate street furniture in the area, the bollards can be said to have a neutral effect on the character and appearance of the Conservation Area.

FIGURE 76. BOLLARDS ON BOTH SIDES OF HIGH STREET

FIGURE 77. BOLLARDS ON HIGH STREET

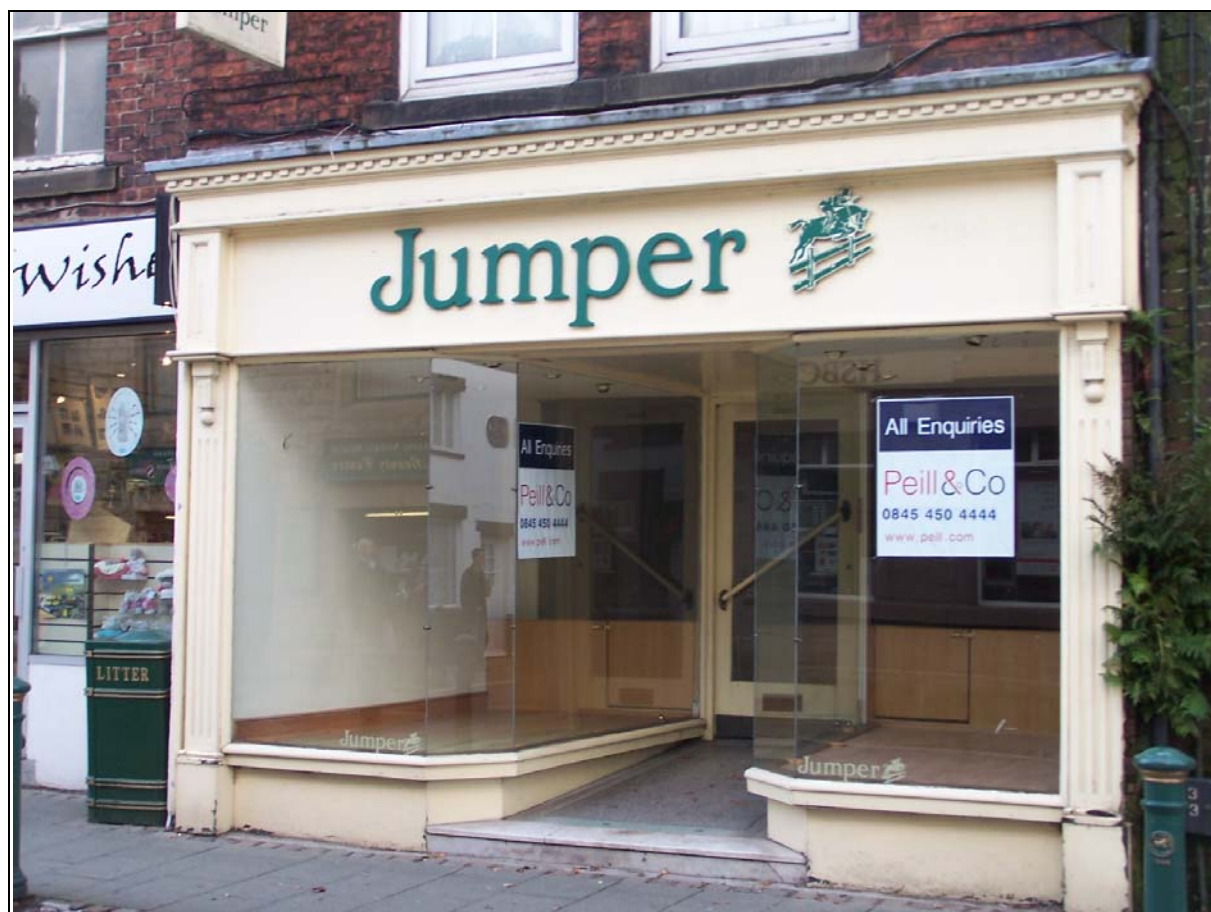
Some shopfronts in Garstang take on this traditional style, though this is mainly resultant from a grant scheme that was run between 2006 and 2008 which gave shop owners the opportunity to receive up to £2,000 or half the amount of works, whichever was least, of grant finance to invigorate and enhance the trading infrastructure and retail image of Garstang as a historic market town. Section 4.9 elaborates on this further in '*Commercial Property Types*'. Figure 79 gives one example of a good traditional shopfront within Garstang.

FIGURE 79. APPROPRIATE SHOPFRONT SIGNAGE

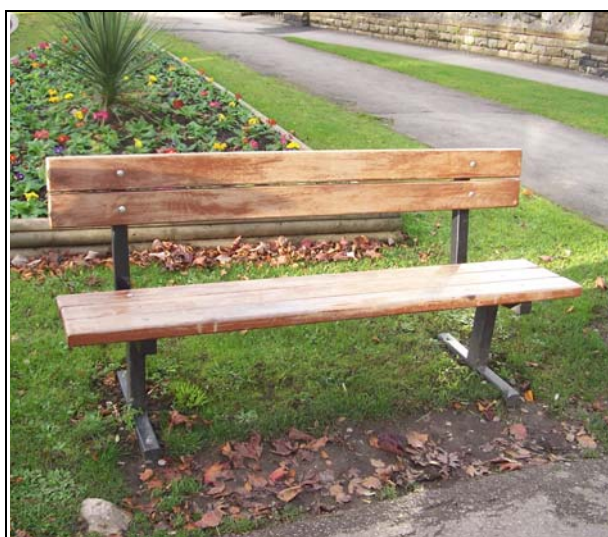
FIGURE 83. BENCH DESIGN

Within Garstang Conservation Area there are two styles of benches as well as differing materials in use. This can cause discontinuity and can attract attention away from the historic character and appearance of the Conservation Area. Consequently, to avoid attention being drawn to the incongruity of these features, these benches should be replaced at some point in the future in favour of one appropriate design and in appropriate materials, and consequently will aid in bringing continuity back into the area.

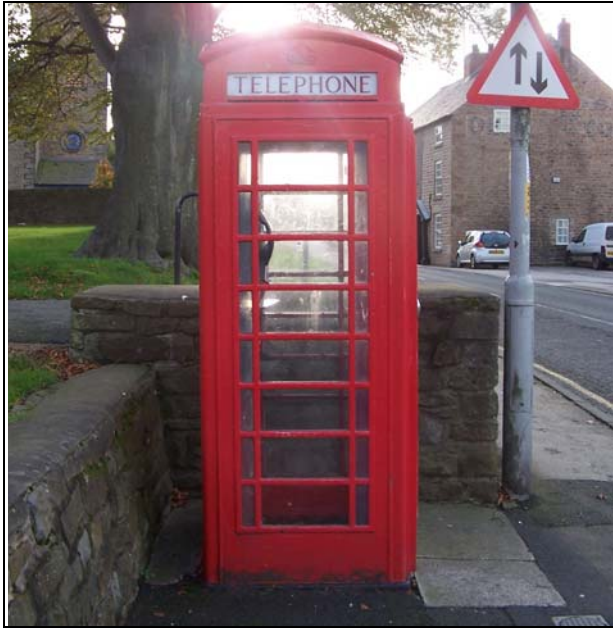
Within the Conservation Area, there are two different designs of telephone box. One follows the traditional K6 red style, and the other is of a more modern design, both of which are shown in Figures 85 and 86 respectively.

While the traditional red telephone box enhances the area as it accentuates the historic character of the area, the more modern design, although not a positive feature, does not detract significantly from the character and appearance of the Conservation Area either. This is due to the standard design of the more modern telephone boxes, which is found in countries across the U.K.

FIGURE 85. TRADITIONAL STYLE OF TELEPHONE BOX

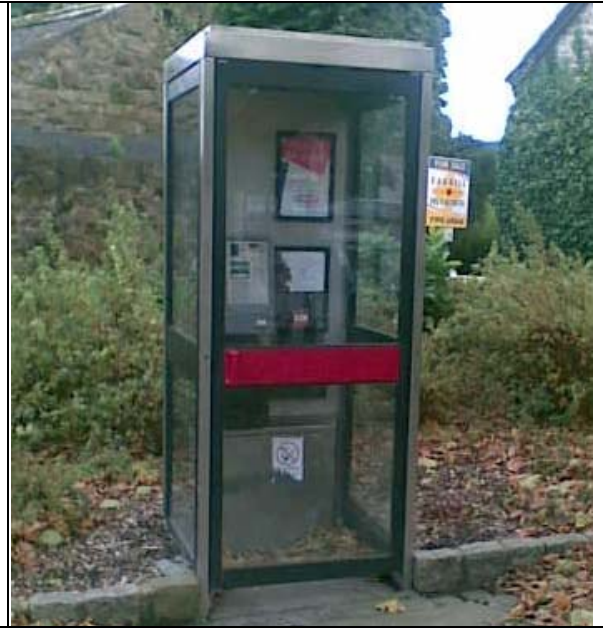
FIGURE 86. MODERN STYLE OF TELEPHONE BOX

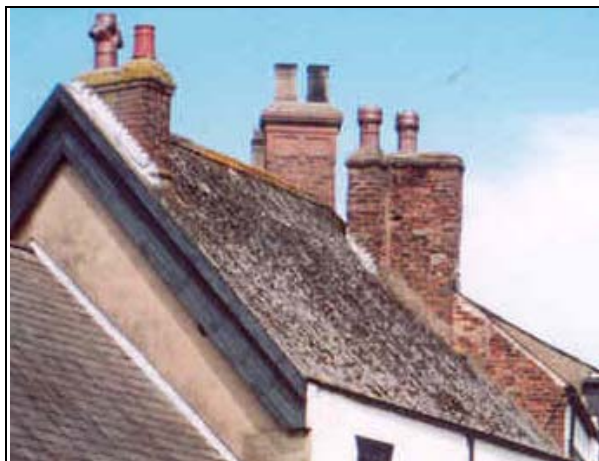
The principal roofing material within Garstang up to and including the nineteenth century was thatch. This would have been a local material that would have been easily available. The continued use of thatch through the early nineteenth century suggests that the town lagged behind its contemporaries in modernizing its building stock, i.e. due to the high risk of fire associated with thatch, many other market towns were at this time sourcing other materials that did not bring the same level of risk. By the mid to late nineteenth century however, slate was used on a third of all buildings, and today no thatched buildings remain within Garstang town centre. However, still in existence are some examples of sheet metal that was sometimes initially used to replace thatch. This can be seen in Figure 100, with Figure 101 illustrating slate roofs.

FIGURE 100. SHEET METAL ROOF

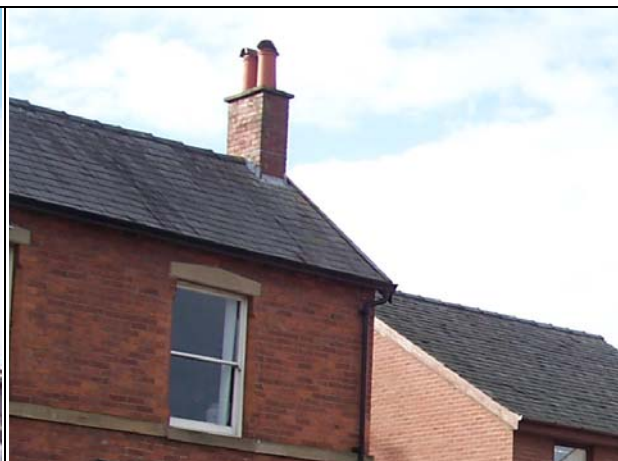
FIGURE 101. SLATE ROOFS

It is an increasing trend for original slates to be replaced with modern equivalents. These are generally constructed of modern materials and in a modern style, for example concrete tiles. This lack of consistency affects both the character and appearance of the Conservation Area, and as such is a negative feature.

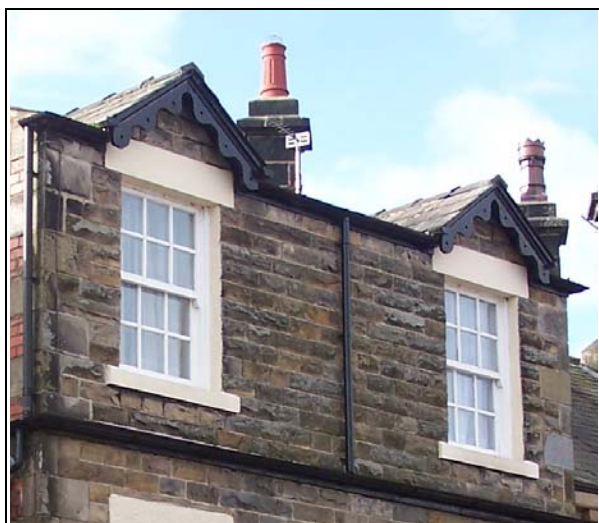
Traditionally, the majority of windows in buildings within the Conservation Area would have been recessed, constructed of timber and more that likely have been of sash and casement design. Unfortunately however, due to the attraction of modern uPVC glazing, a more readily available and relatively cheap materials by comparison to traditional timber, many of these windows have been lost. Figures 102 to 105 give examples of traditional window styles and their inappropriate modern replacements.

FIGURE 102. SASH AND CASEMENT WINDOWS,
BRIDGE STREET

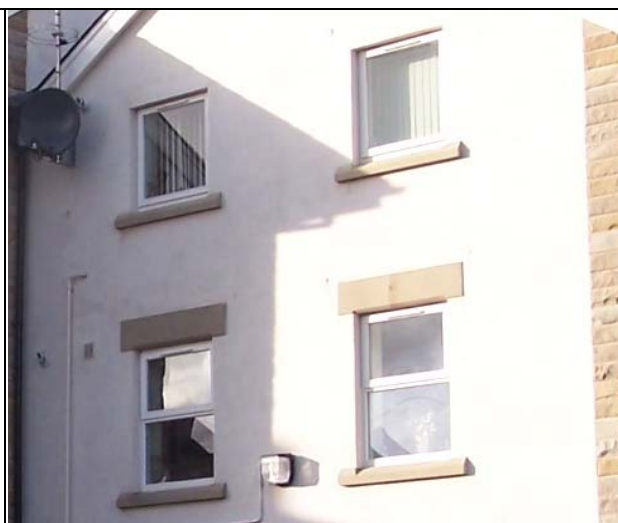
FIGURE 103. MODERN UPVC WINDOWS

Within Garstang Conservation Area, more timber sash and casement windows are being replaced with uPVC. UPVC is a modern material, and as such should be discouraged as inappropriate and incongruous within Conservation Areas as standard. Timber is a traditional material and consequently should be promoted in all circumstances. Good examples where timber sash and casement windows remain in situ are illustrated in Figures 110 and 111. Figure 112 shows an appropriate replacement timber sash and casement window, while Figure 113 illustrates inappropriate modern mock sash and casement uPVC windows.

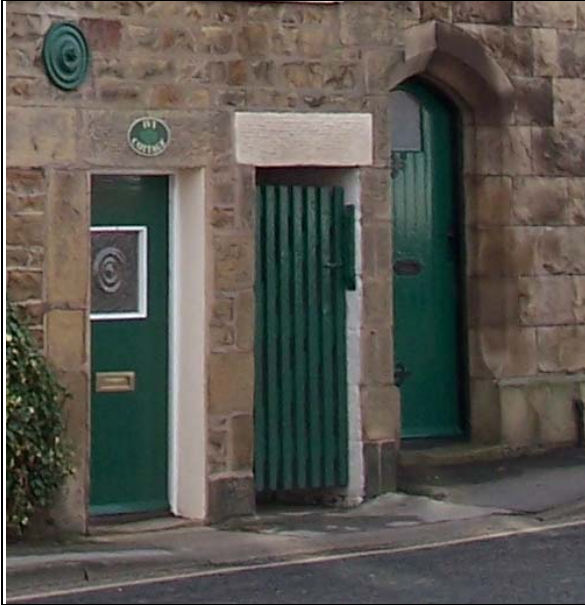
FIGURE 104. TIMBER DOORS, BRIDGE STREET

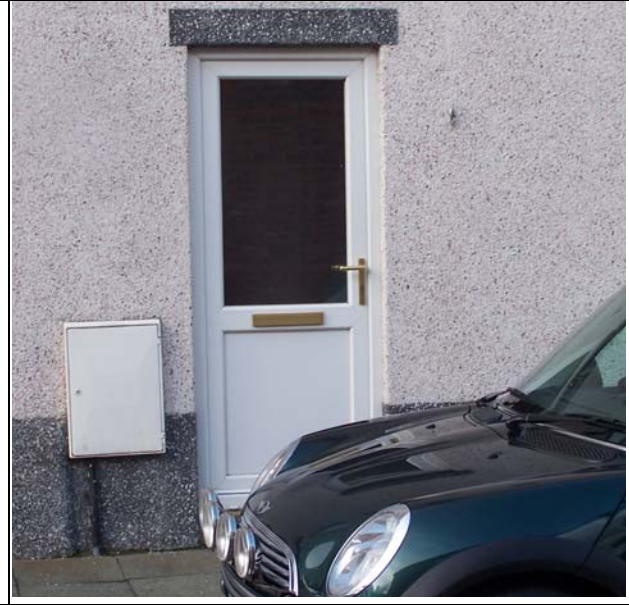
FIGURE 105. MODERN UPVC DOORWAYS

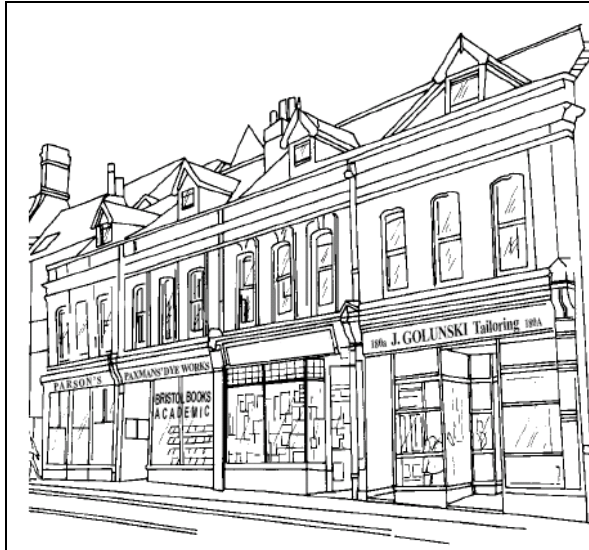
Traditional fascia signs should be an integrated part of the overall design and the use of hand painted timber fascias is encouraged. Fascia boards should be angled down towards pedestrians rather than parallel to the front face of the building and therefore directed at the horizon. Lettering should be clear and unambiguous – often the shop name alone is sufficient. They should be sign written or made up of individually applied letters that are appropriate in scale, colour and typeface to the building. Good general examples of fascia signage are shown in Figure 106, with inappropriate styles illustrated in Figure 107.

FIGURE 106. GOOD EXAMPLES OF TRADITIONAL FASCIA SIGNAGE
