Garstang Conservation Area Appraisal and Management Plan

Garstang Conservation Area Appraisal

Wyre Borough Council

Adopted 19th July 2010

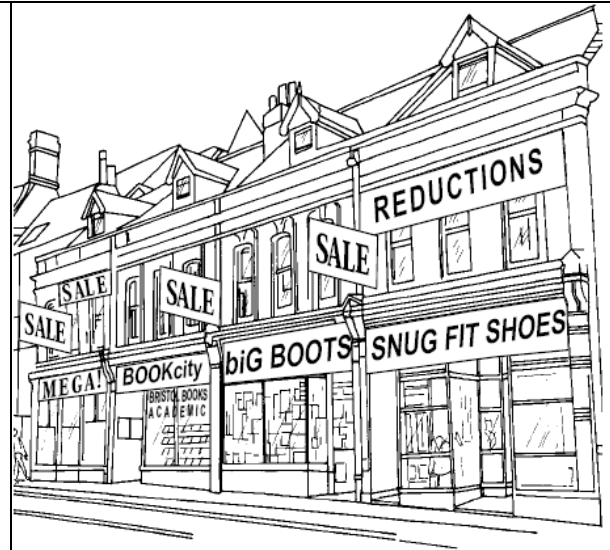
Traditional fascia signs should be an integrated part of the overall design and the use of hand painted timber fascias is encouraged. Fascia boards should be angled down towards pedestrians rather than parallel to the front face of the building and therefore directed at the horizon. Lettering should be clear and unambiguous – often the shop name alone is sufficient. They should be sign written or made up of individually applied letters that are appropriate in scale, colour and typeface to the building. Good general examples of fascia signage are shown in Figure 106, with inappropriate styles illustrated in Figure 107.

FIGURE 107. INAPPROPRIATE LARGE SCALE FASCIA SIGNAGE

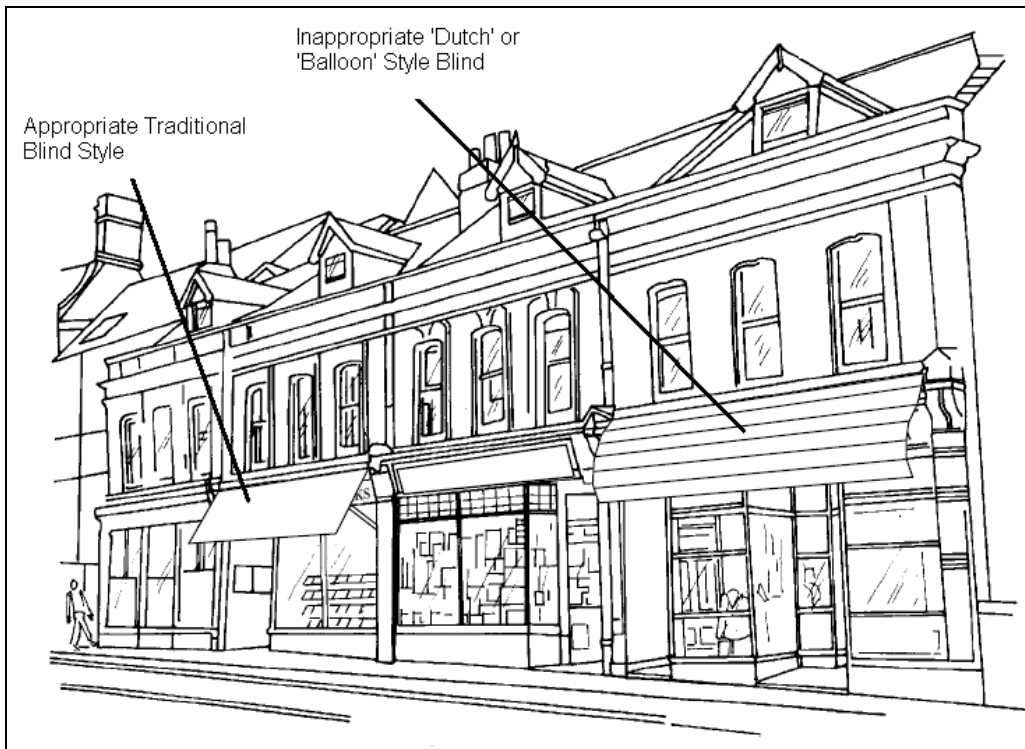
Blinds and canopies are designed to protect goods on display from the harmful effect of exposure to direct sunlight. They should be retractable to ensure that the fascia is not permanently obscured, with blind boxes incorporated into the overall shop front design. Permanent balloon canopies or Dutch blinds, which are out of character with an historic area, should be avoided. Figure 108 helps to illustrate this.

FIGURE 108. TRADITIONAL APPROPRIATE AND MODERN INAPPROPRIATE BLIND STYLES

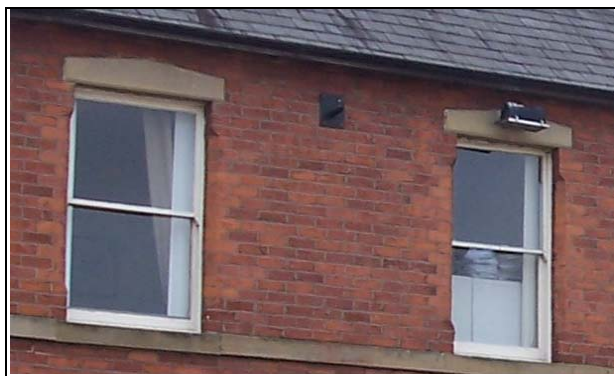
Within Garstang Conservation Area, more timber sash and casement windows are being replaced with uPVC. UPVC is a modern material, and as such should be discouraged as inappropriate and incongruous within Conservation Areas as standard. Timber is a traditional material and consequently should be promoted in all circumstances. Good examples where timber sash and casement windows remain in situ are illustrated in Figures 110 and 111. Figure 112 shows an appropriate replacement timber sash and casement window, while Figure 113 illustrates inappropriate modern mock sash and casement uPVC windows.

FIGURE 110. GOOD EXAMPLE OF SASH AND CASEMENT WINDOWS

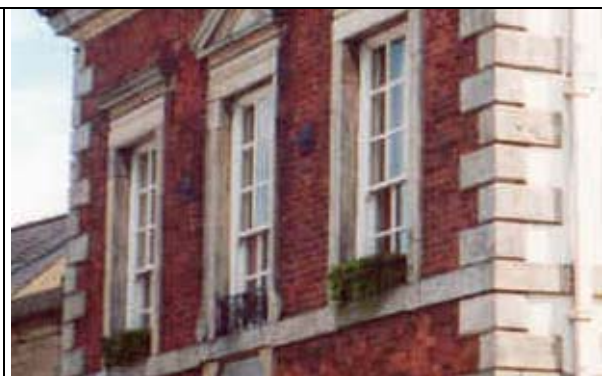
FIGURE 111. GOOD EXAMPLE OF A SASH AND CASEMENT WINDOWS

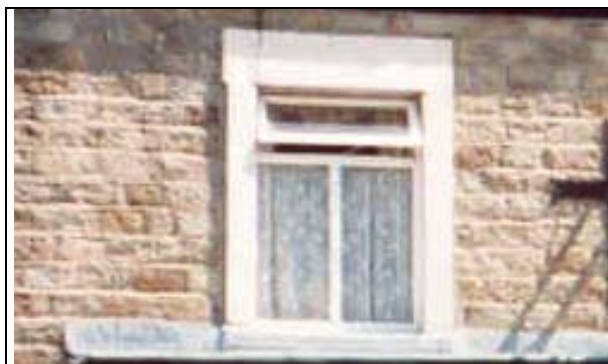
FIGURE 112. INAPPROPRIATE REPLACEMENT WINDOWS

Common reasons given for replacing windows are that they are draughty or rotten, or that they stick or cannot be opened (Environment & Heritage Service, 2007). An experienced joiner can rectify all of these problems, and serious consideration should always be given to conservation of existing windows rather than complete replacement: not only for aesthetic reasons but also economic.

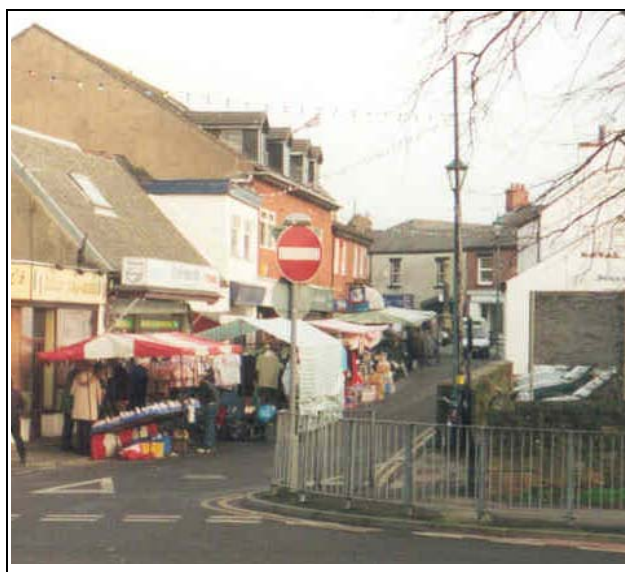
Traffic can be a big problem in Garstang Conservation Area. This is mainly due to the one-way system through High Street and Park Hill Road. This can be a particular problem on Wednesdays, Market Day. On Market Day, stalls are generally erected along the west side of the single lane High Street, meaning that for vehicles to move through the area, movement is extremely restricted. This is shown in Figures 114 and 115. The issue with traffic is further illustrated when delivery lorries and trucks attempt to drop off goods, and unintentionally block the road in its entirety. One possible solution may be to pedestrianise High Street.

FIGURE 114. MARKET DAY IN GARSTANG

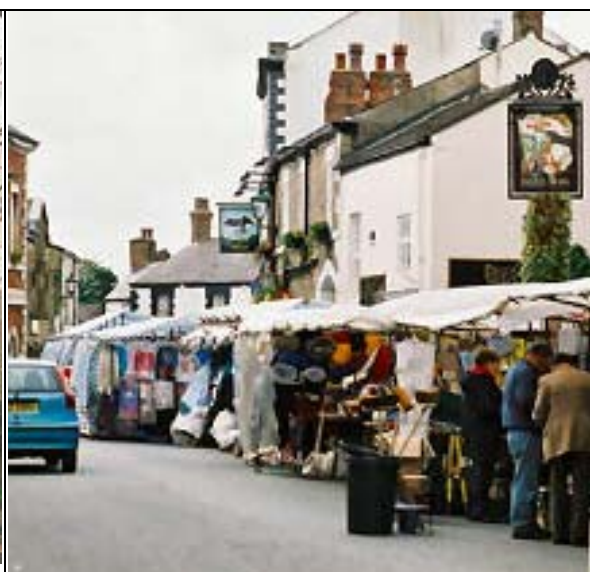
FIGURE 115. MARKET STALLS RESTRICTING TRAFFIC MOVEMENT

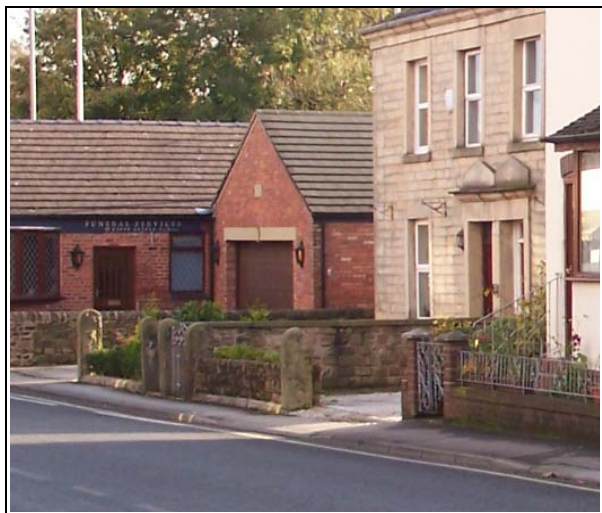
Therefore, not only does paving over garden areas increase the risk of flooding, it can also add to pollution problems and not only effect wildlife, but also industrial and agricultural water sources. The Communities and Local Government guidance, and the changes to permitted development rights, should help in reducing these problems for the future, but all current impermeable hardstanding areas will continue to be an issue until their replacement. Consequently this is a negative factor not only with regard to the character and appearance of the Conservation Area, but also the wider environment as a whole.

FIGURE 116. FRONT GARDEN LOST IN FAVOUR OF OFF STREET PARKING, LIABLE TO INCREASE FLOODING

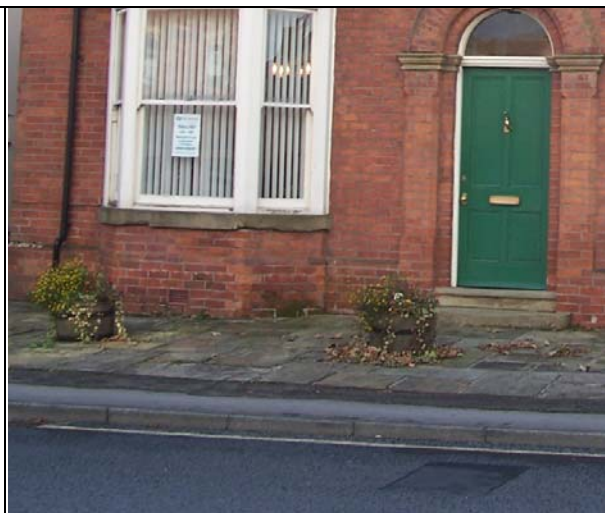
FIGURE 117. LOSS OF FRONT GARDEN RESULTING IN INCONGRUOUS OPEN SPACE

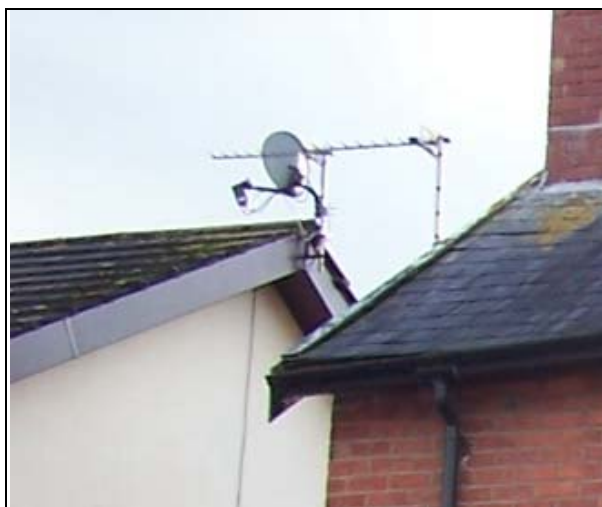
A further threat to the character and appearance of Garstang Conservation Area is the increasing appearance of satellite dishes on the front elevation of properties. Often an unknown fact is that the siting of a satellite dish on the chimneystack or on the roof slope or elevation fronting the road requires Planning Permission from the Council. This does not mean, however, that satellite dishes are prohibited within a Conservation Area, they are simply encouraged to be placed out of view, on the rear of properties if feasible. Examples where satellite dishes have been placed on inappropriate elevations are illustrated in Figures 118 and 119. This is likely to be the result of being unaware of the rules that surround Conservation Areas. Appendix 8.4 details the effect of Conservation Area designation.

FIGURE 118. INAPPROPRIATELY PLACED SATELLITE DISH

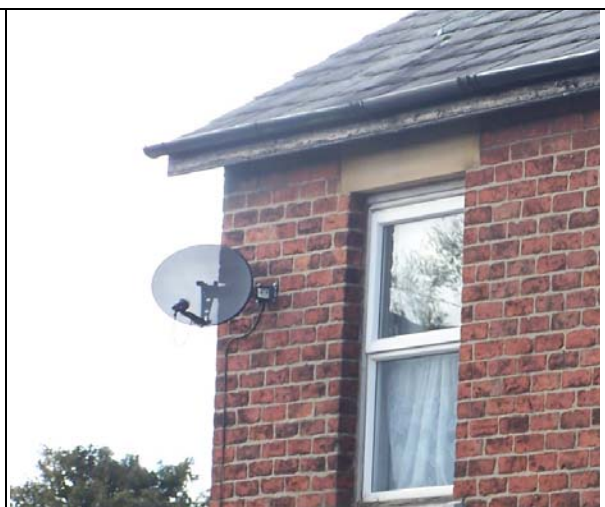
FIGURE 119. INAPPROPRIATELY PLACED SATELLITE DISH

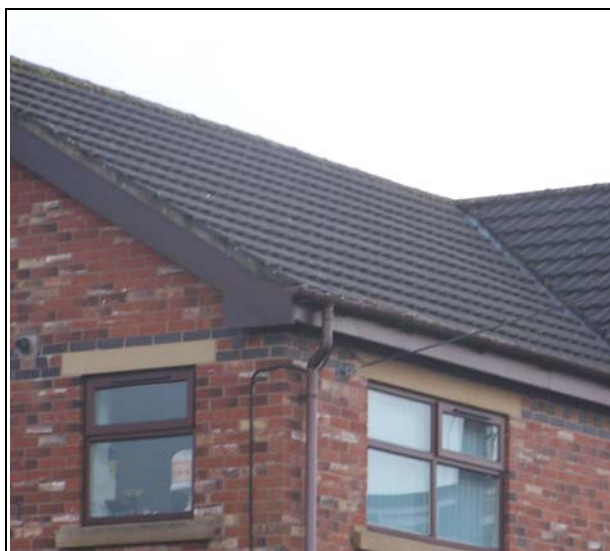
It is an increasing trend for original slates to be replaced with modern equivalents. These are generally constructed of modern materials and in a modern style, for example concrete tiles. This lack of consistency affects both the character and appearance of the Conservation Area, and as such is a negative feature.

FIGURE 120. CONCRETE ROOF TILES

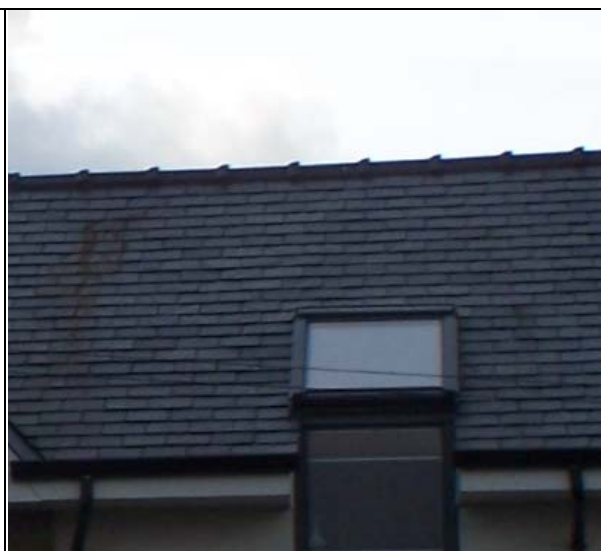
FIGURE 121. MODERN 'SHINY' SLATES

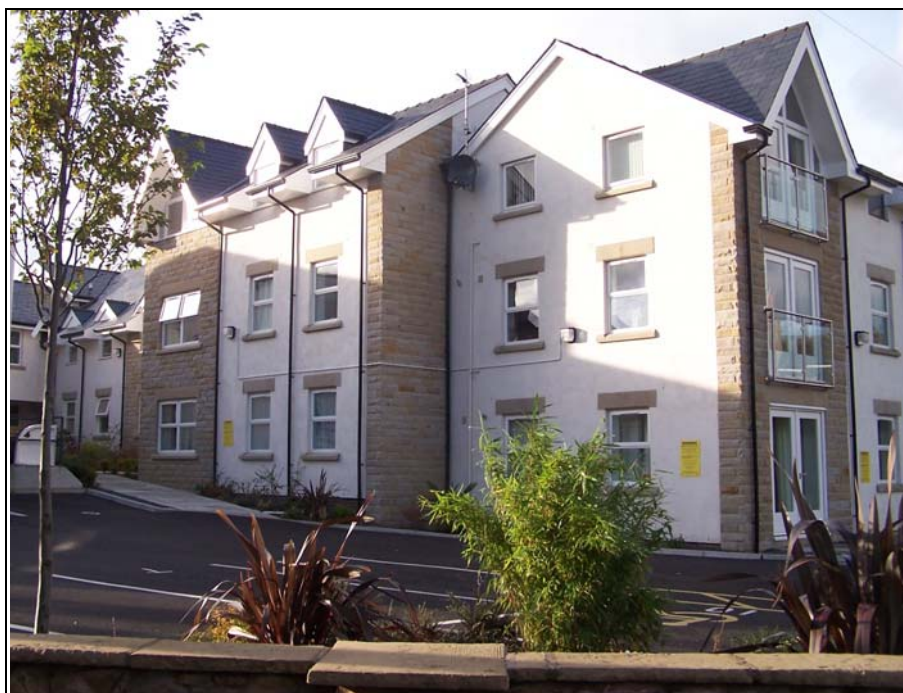
The buildings within a Conservation Area are constantly evolving to keep up with modern requirements and trends. Although this is not discouraged, it is essential for the character and appearance of the Conservation Area, that any changes or alterations to buildings are completed with respect for the historic surroundings. One example of where this has not happened, to the detriment of the Conservation Area, is the previous site of the Masonic Hall. Although the Masonic Hall was not of particular benefit to the character or appearance of the area, the new buildings that have been constructed in place also do not make a positive impact on the Conservation Area. Planning Policy Guidance 15 states that where a building “makes no positive contribution...to the character or appearance of the area; their replacement should be a stimulus to imaginative, high quality design, and seen as an opportunity to enhance the area”. This guidance does not appear to have been followed, as shown in Figure 122.

FIGURE 122. NEW REPLACEMENT FLATS

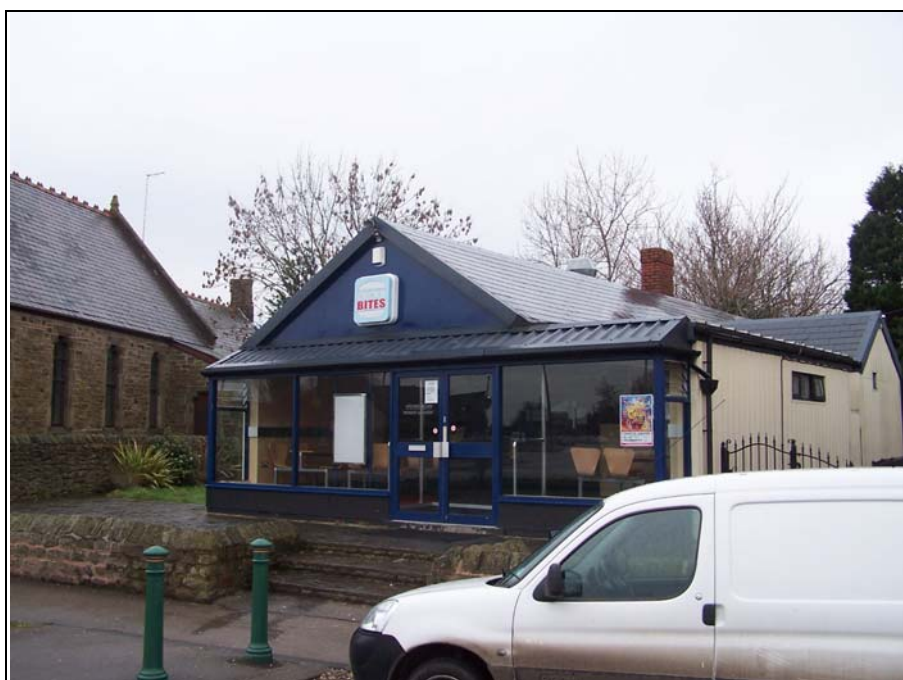
Another modern development that has taken place, which is not in keeping with the character or appearance of the Conservation Area, is that of 'Big Bites' situated on Park Hill Road. This commercial property appears to be shut but is considered to be of negative impact on the historic character of the Conservation Area. It is of inappropriate design and materials, as shown in Figure 123, for its location within Garstang Conservation Area.

FIGURE 123. BIG BITES
