Wyre Making Space For Water Meeting

Minutes of meeting held Thursday 23 February 2023 at Wyre Civic Centre and via Microsoft Teams.

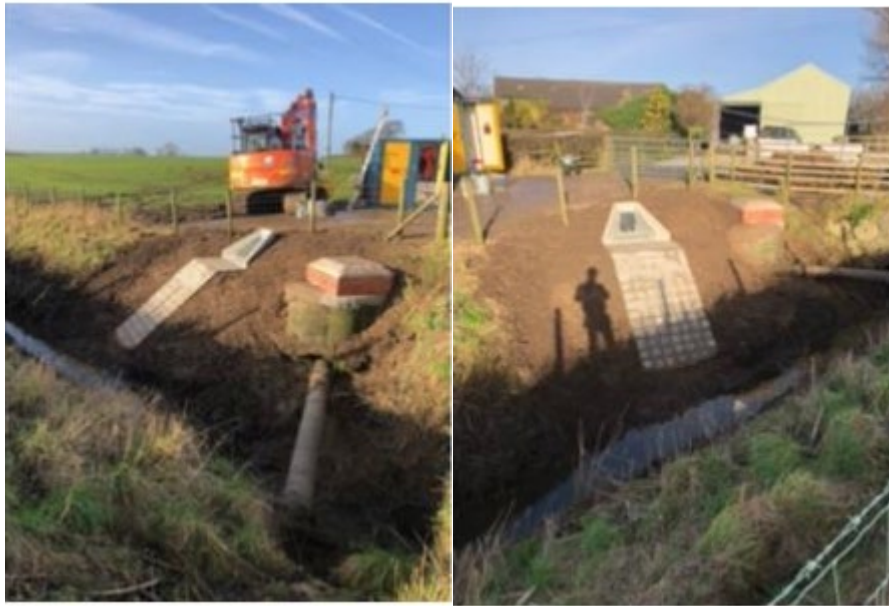
- PW reported that UU have completed the construction of an emergency overflow from the pumping station on Rawcliffe Road St Michaels (Issue & Actions ref 19/20). The construction was completed at the end of January and should hopefully stop further flooding of the highway.

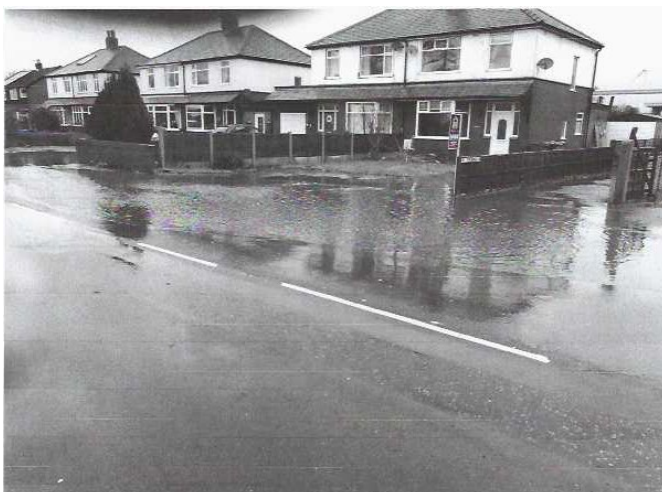
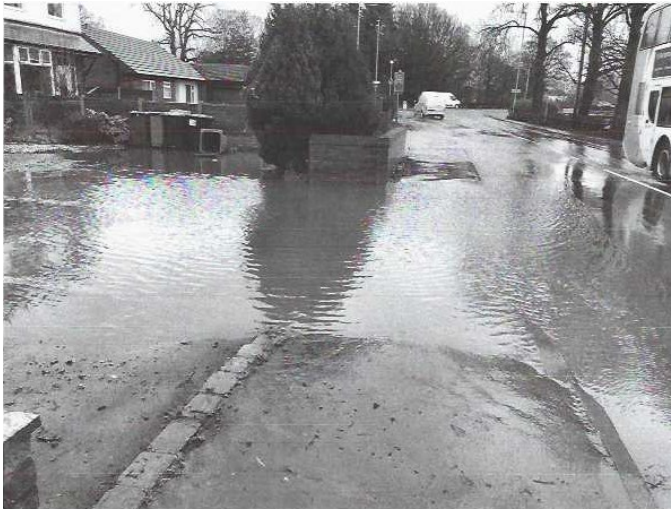
The Avenue - 15 January 2023

13 Jan 2023 - Flooding again on the Avenue and front gardens. Peaked at about 2pm to 3pm (river level about 1.20m)

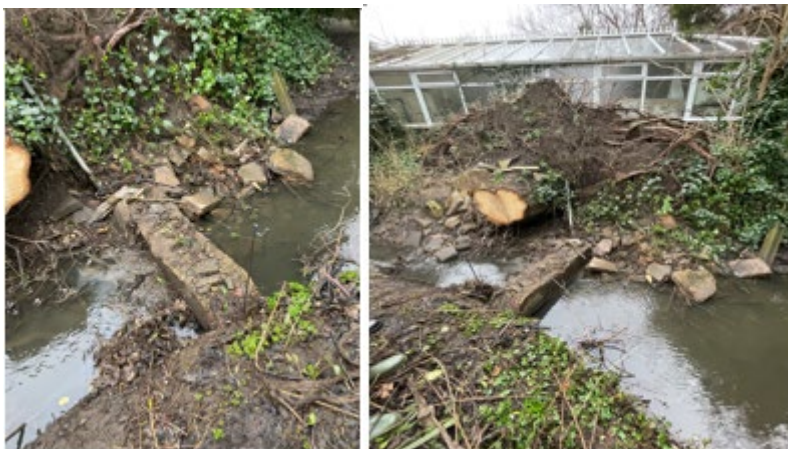
It's obvious from the pictures below that the tree has collapsed and brought a fence and associated hard paving down with it. The section in the dyke is a mixture of concrete and bricks which should easily be broken up to ease removal. It is holding back water but there is a small flow underneath. We have checked at both ends and there is no connection into the banks and no power or drainage within. This tree was recently removed by EA operatives and access is easy. We have a key to the crossing gates and so can provide access.

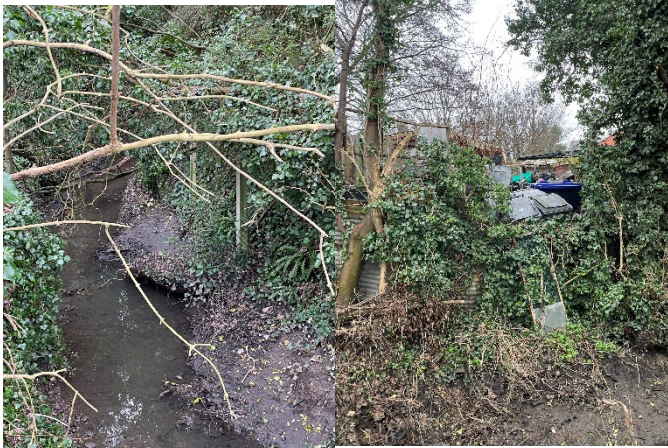
In the same area you can see the delicate state of refuse bins etc in the garden overlooking the dyke. From the road can be seen the collapsed wire mesh fencing now falling into the dyke.

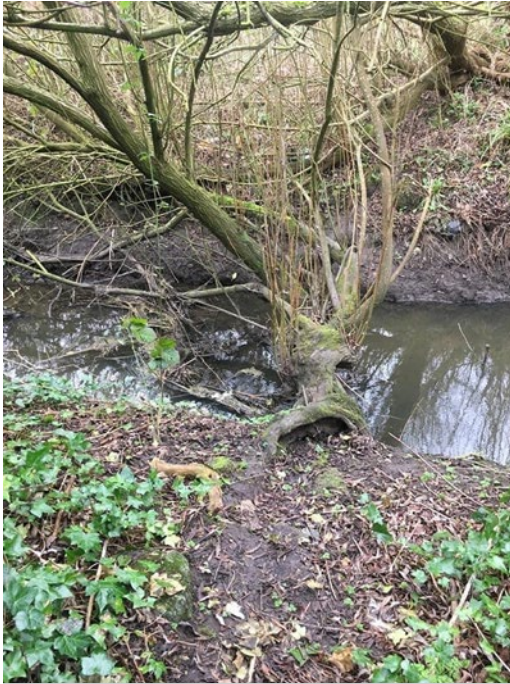
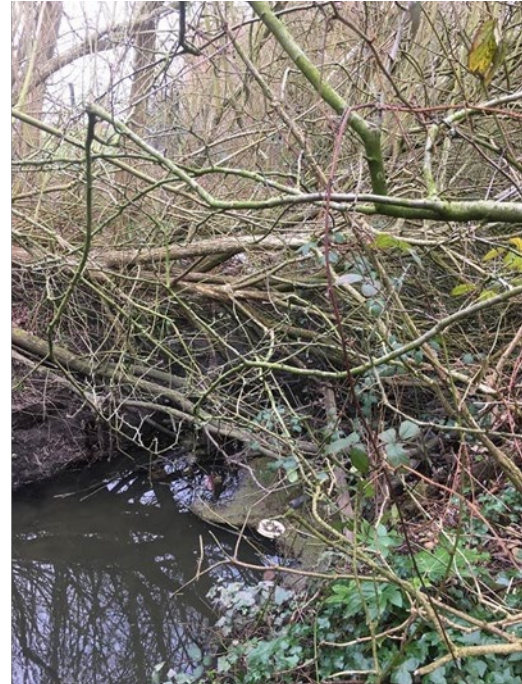
Continuing south out of the railway area and into New Lane we have the following issue.

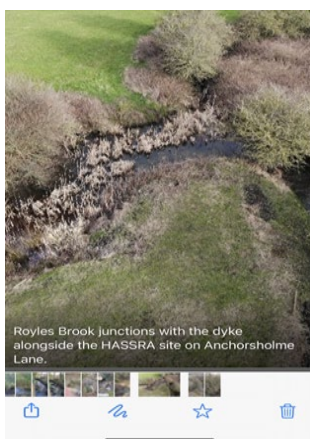
This blockage has grown and is now spreading into Royles Brook and before too long it will start to impede the flow from White Carr Lane. I believe you have requested the EA to do the work in the past and this issue is now becoming more serious.

This is an aerial photo but gives a better view of how the blockage is spreading. The top of the picture is the dyke from Anchorsholme lane and the right leg from White Carr Lane.

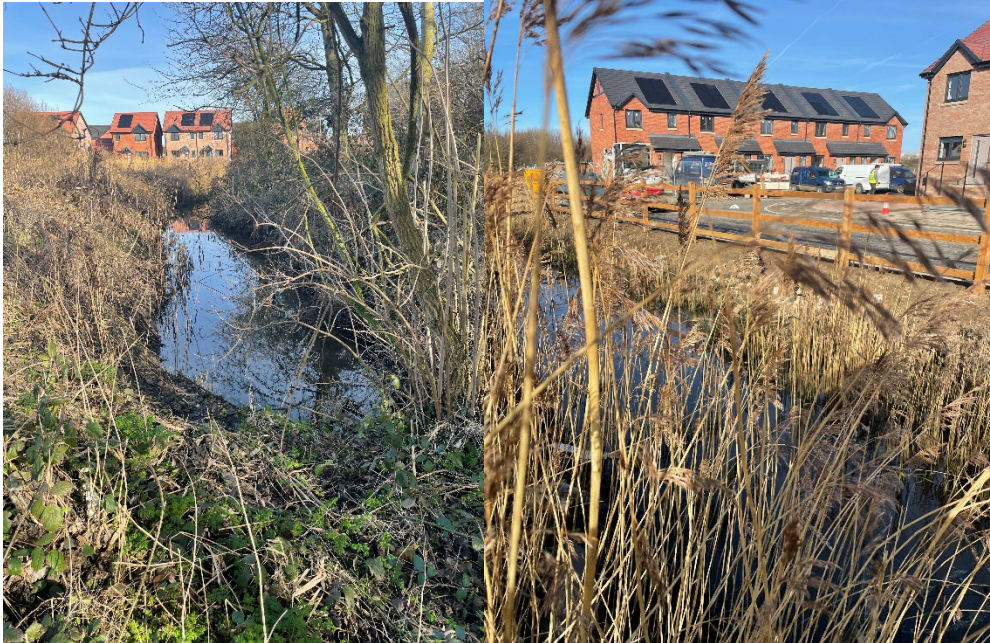
With regard to north Thornton the dyke which runs from the Pheasant Wood site (SA1/3) under Fleetwood Rd North and onto the Dickie and Moore site past the large corner house which is a mower business the dyke looks as though it is blocked

further downstream. We are not sure if is blocked on the development site which has just been refused planning or the Dickie and Moore site.

Further investigation is required but this dyke drains from the Pheasant Wood estate and must be free flowing.

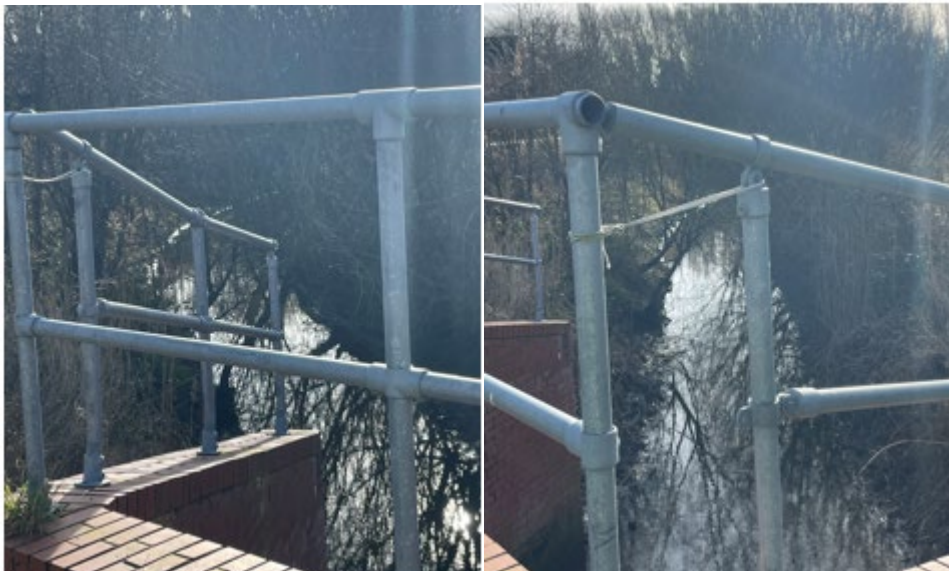
The safety handrails which we temporarily tied up with string a few years ago have still not been repaired on Hawley Gardens. See the following photos.

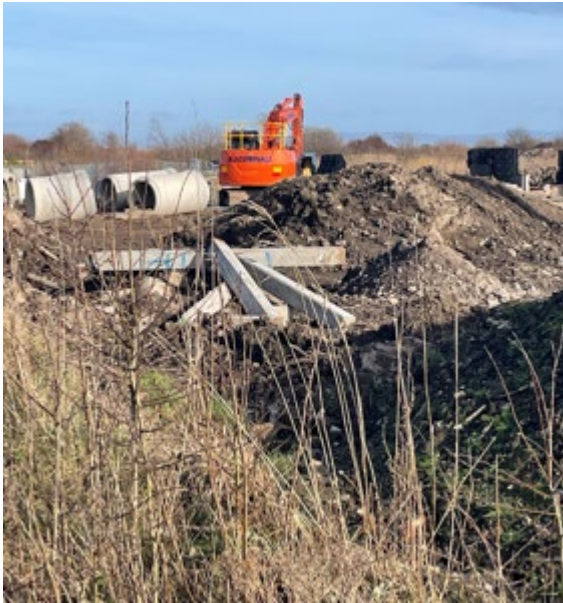
Our team have asked if we can visit the Power Station site to look at the culverted system and find out the inspection regime going forward. Has anyone from planning been to visit the site to check on progress to ensure the drainage system is being constructed to good standards and as to agreed plans?

Below is a photo taken a couple of days ago.
